Transmission Line 637
San Diego Gas and Electric
“The Witch Fire 2007”
“The Cedar Fire 2003”

Transmission Line 682
“The Paradise Fire 2003”

Presented by:
Ed Clark
The Electrical Expert
<http://www.TheElectricalExpert.com>

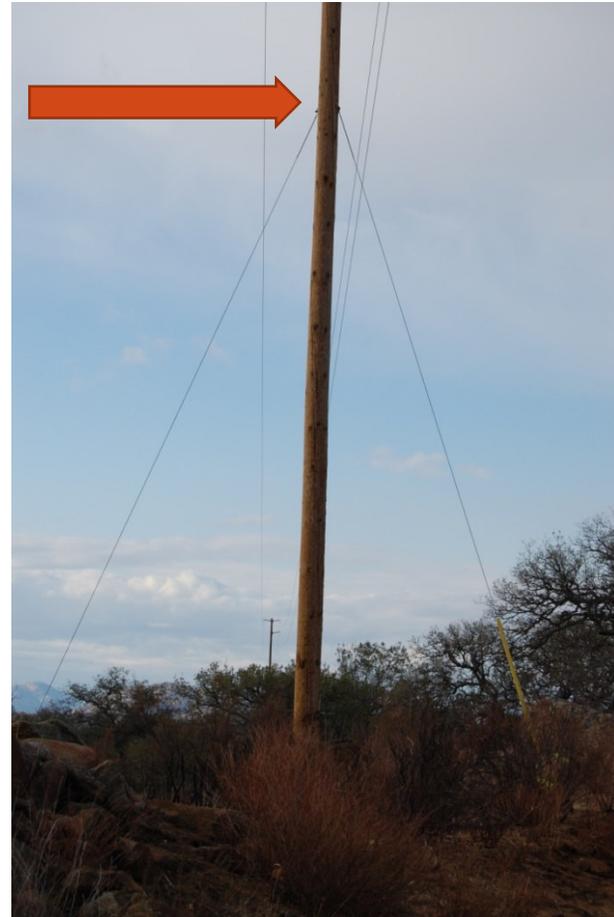
**1. Attached at same location on pole
“WRONG”**

**2. Insulators not utilized!
“WRONG”**

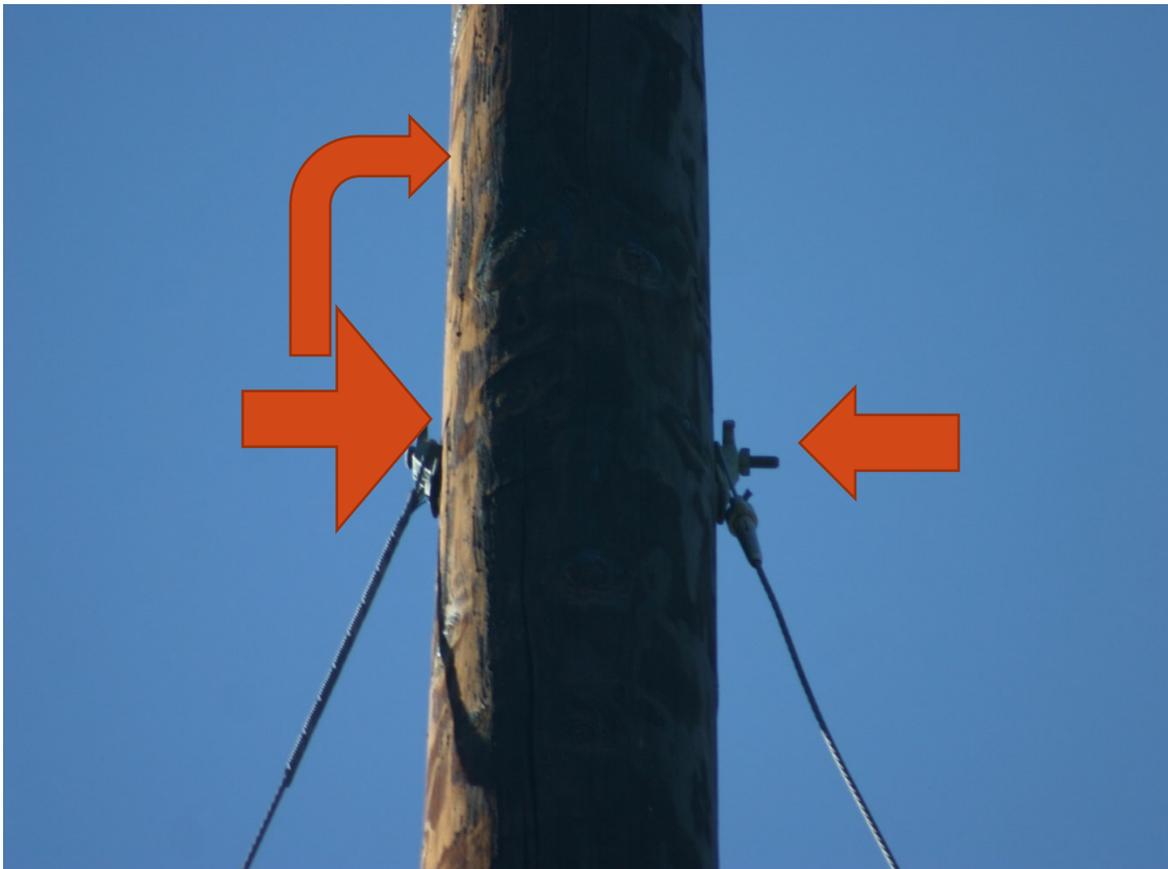
Down Guys Attached at the Same Point :
“WRONG”

**“ Must have
12 inches
Vertical
Clearance or
use
Insulators”**

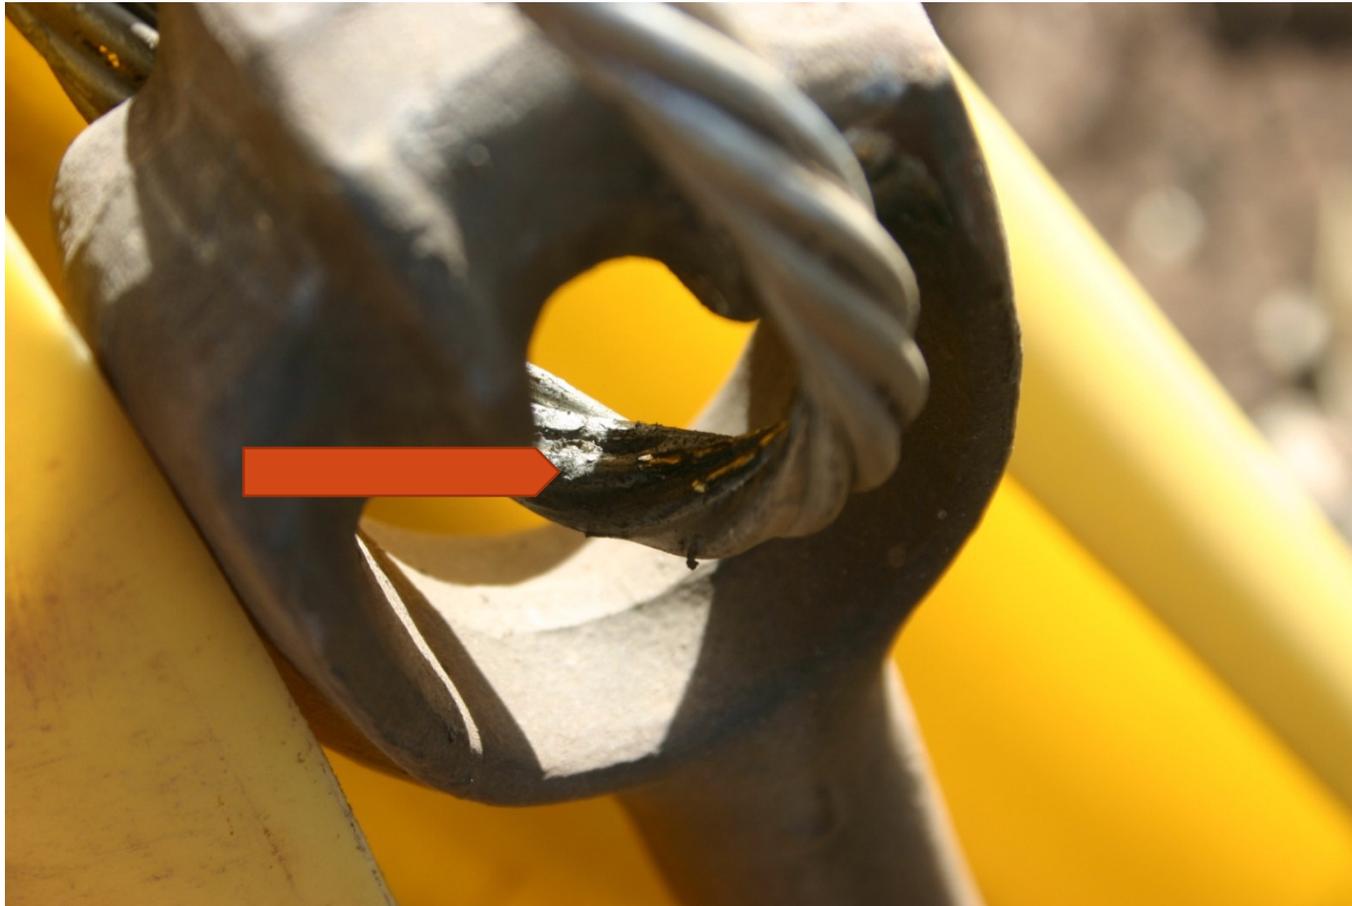
Down guys attached at the same point
allows current to flow:
LOOSE CONNECTIONS = ARCING

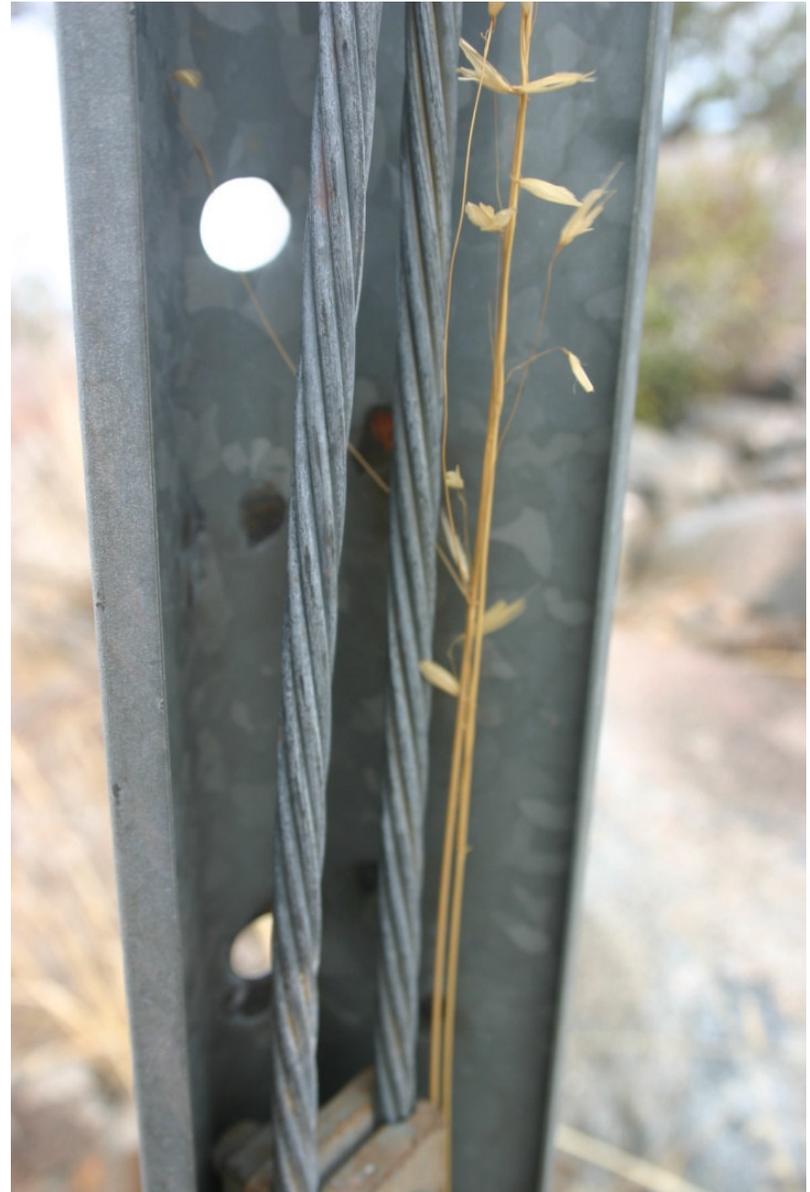
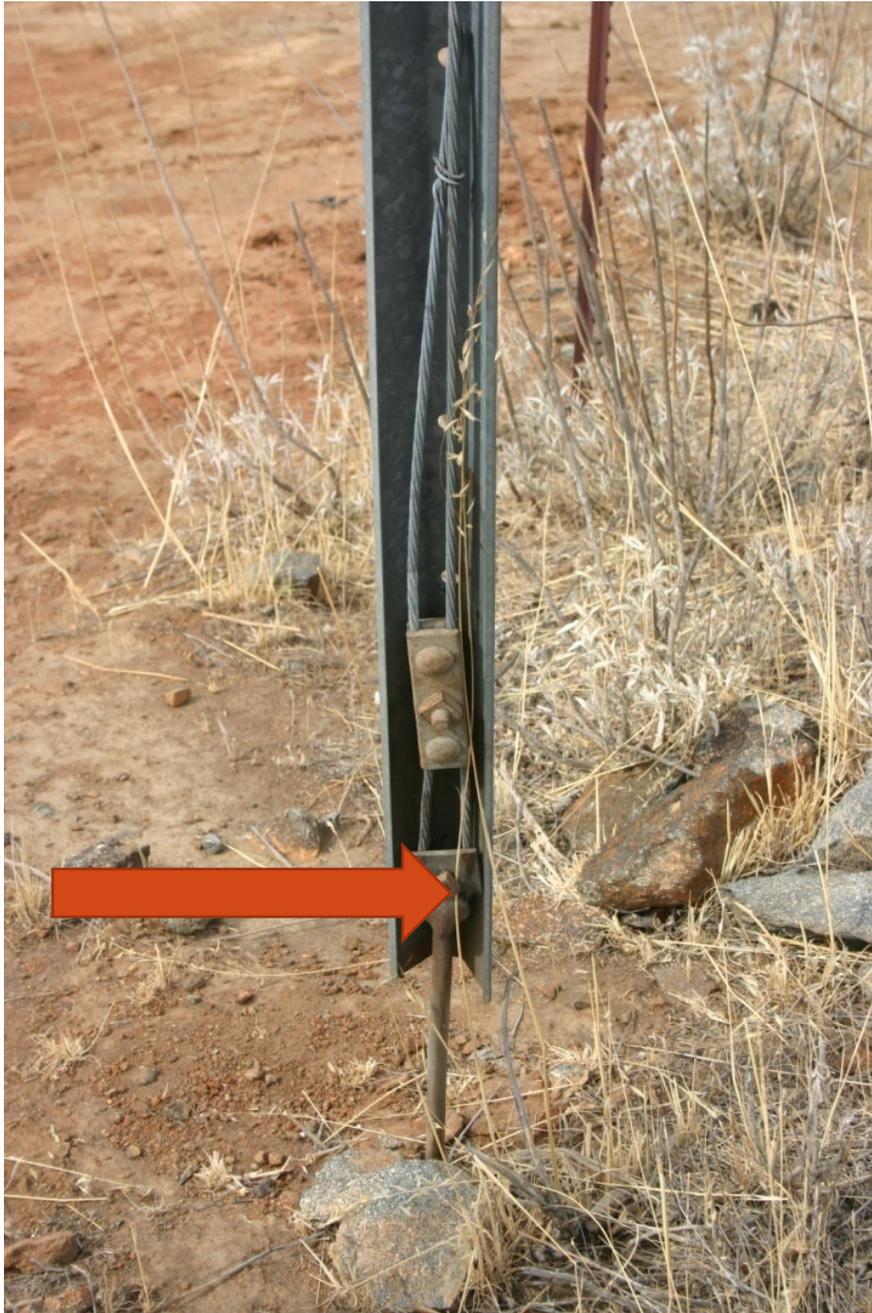
Dry Brush
Arcing
Low Humidity
High Winds

Dry Grass
+
Arcing

Dry Grass
=
Fuse for Fire

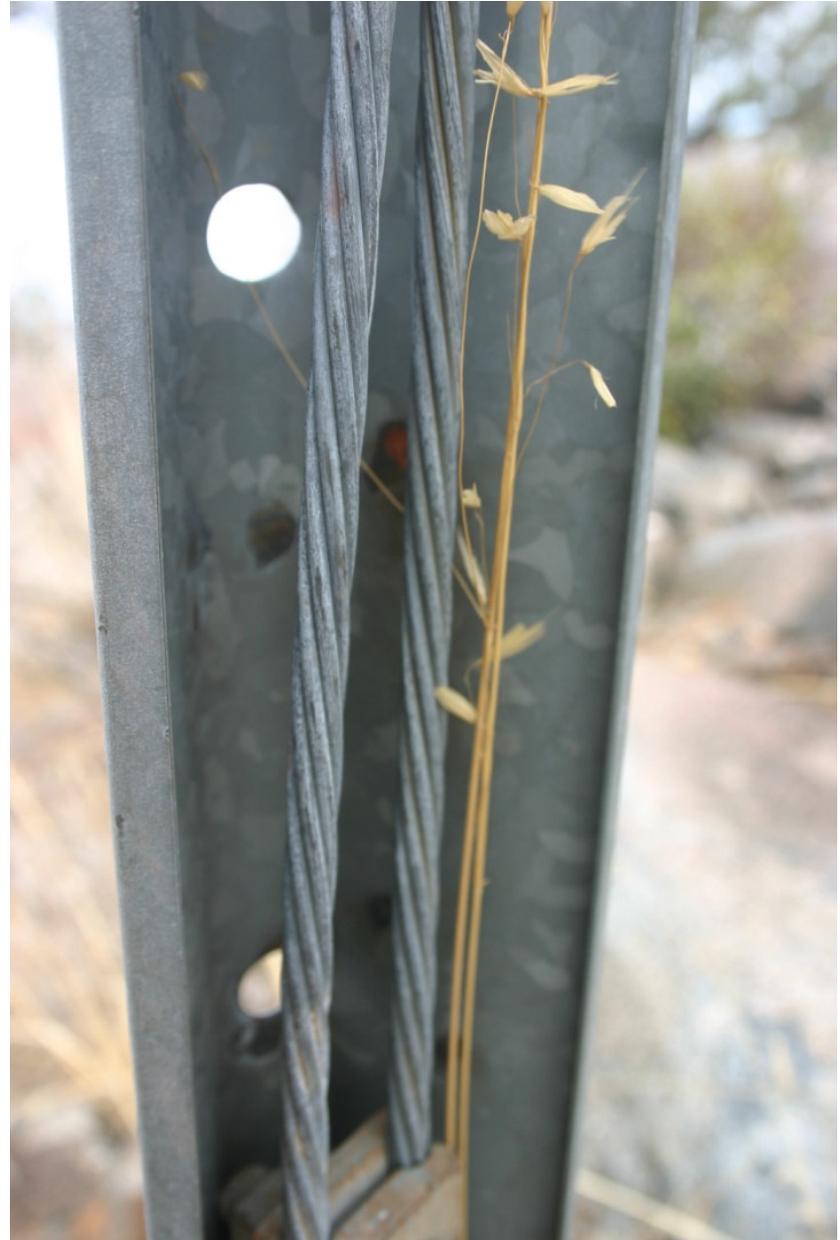
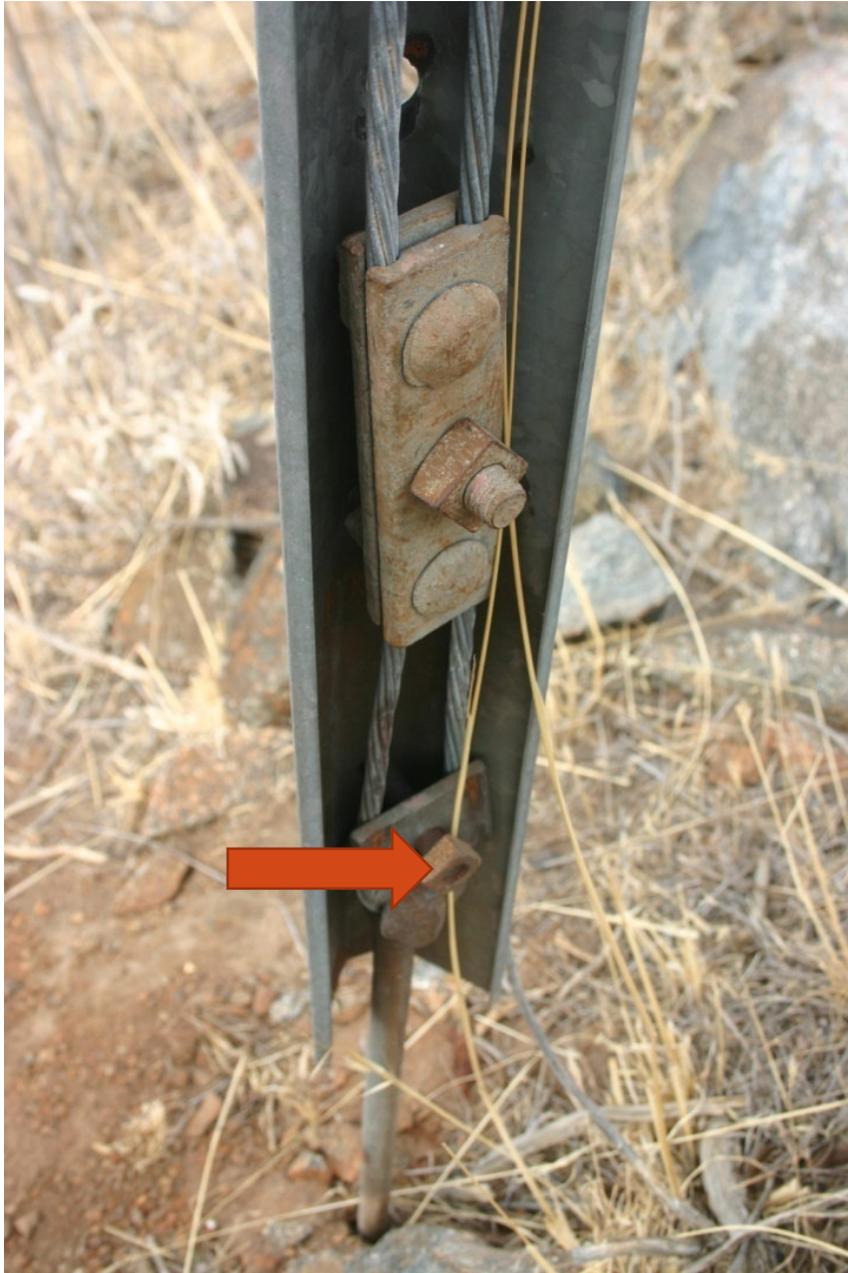
Dry Grass at
Point of
Arcing

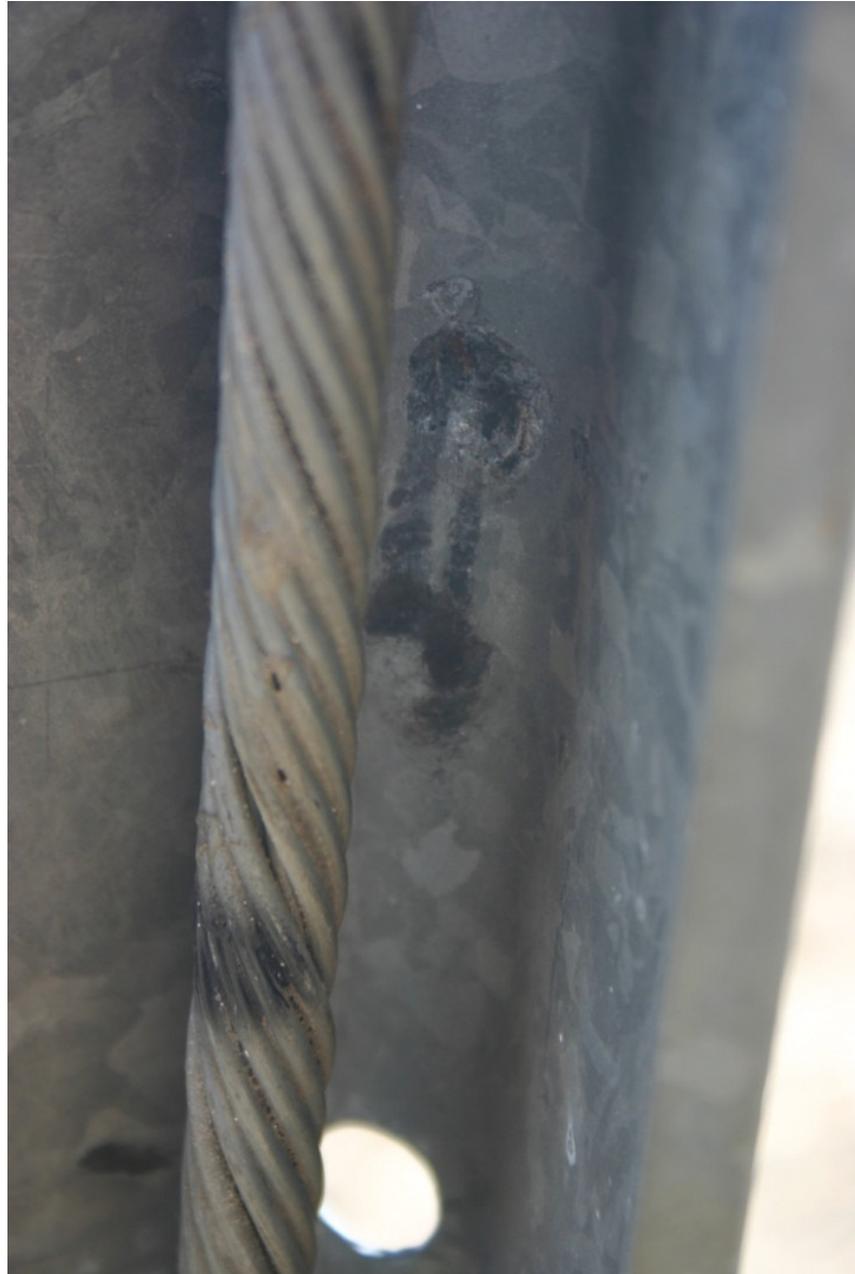
More Arcing

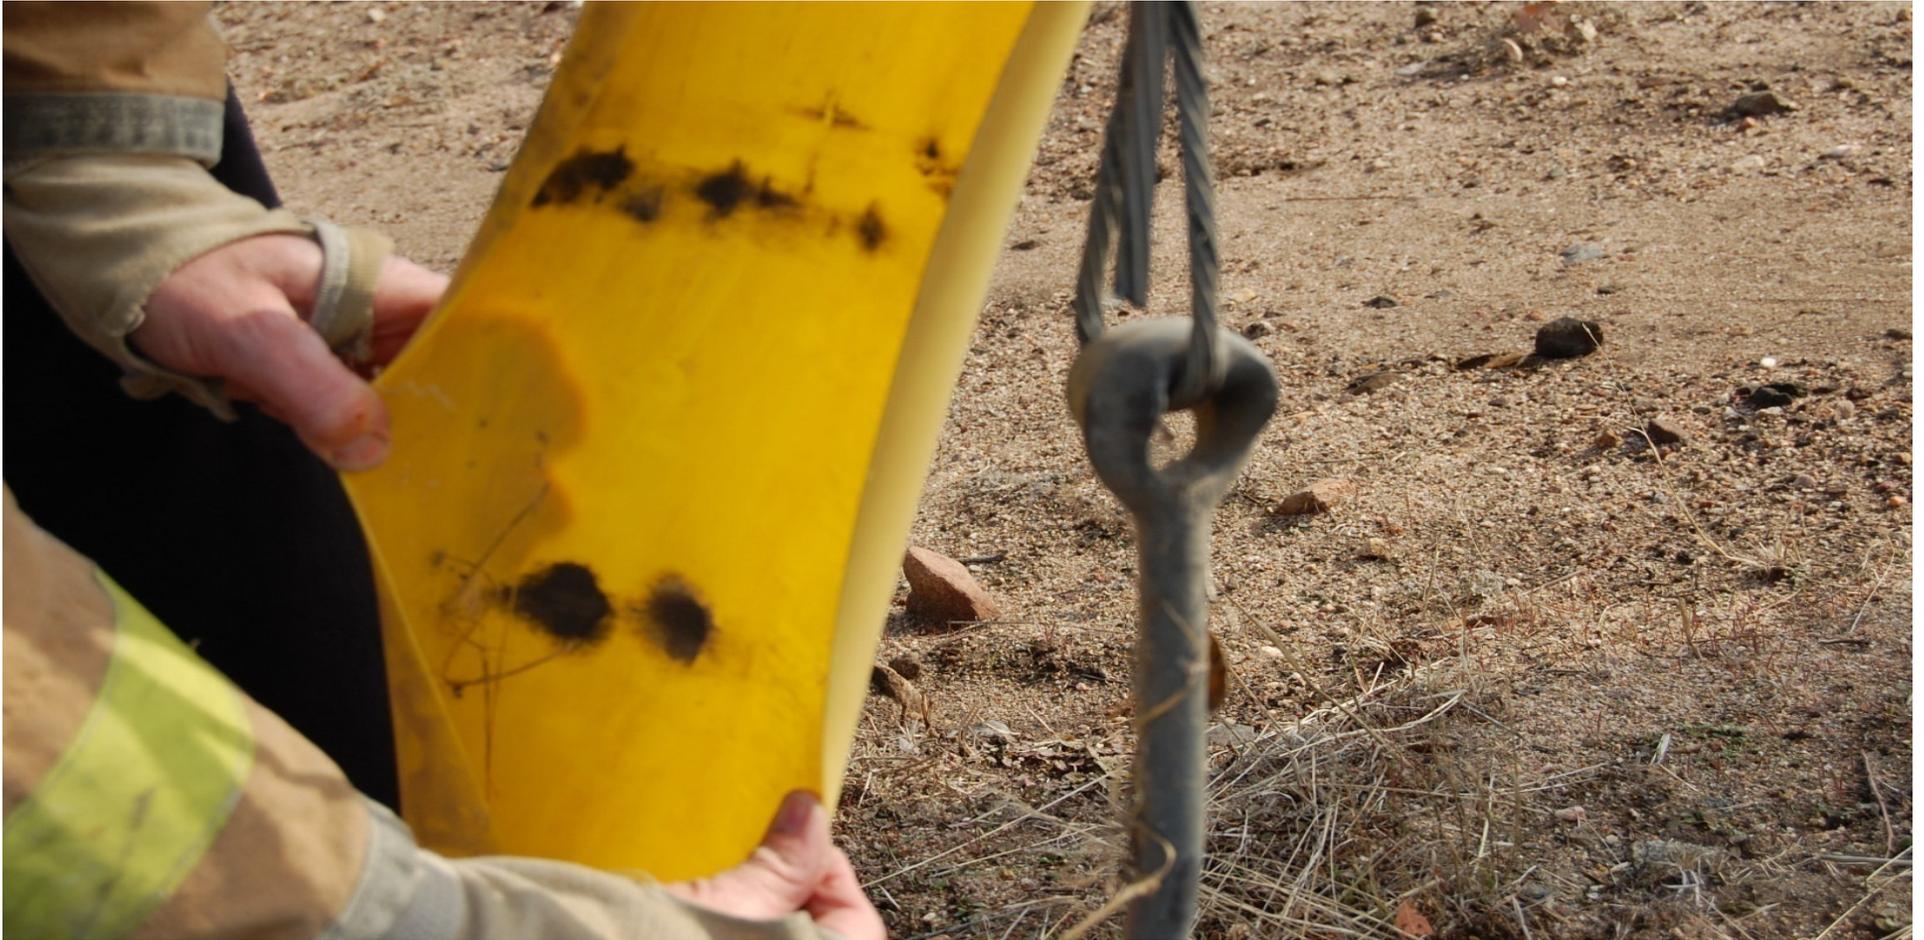
Lab Reports show the following:

O,C,Si,Fe,Zn,Al,Ca,Mg,K, i

Note: This particular sample was from the “CEDAR FIRE”

Lab results show high contents of Carbon from ARCING

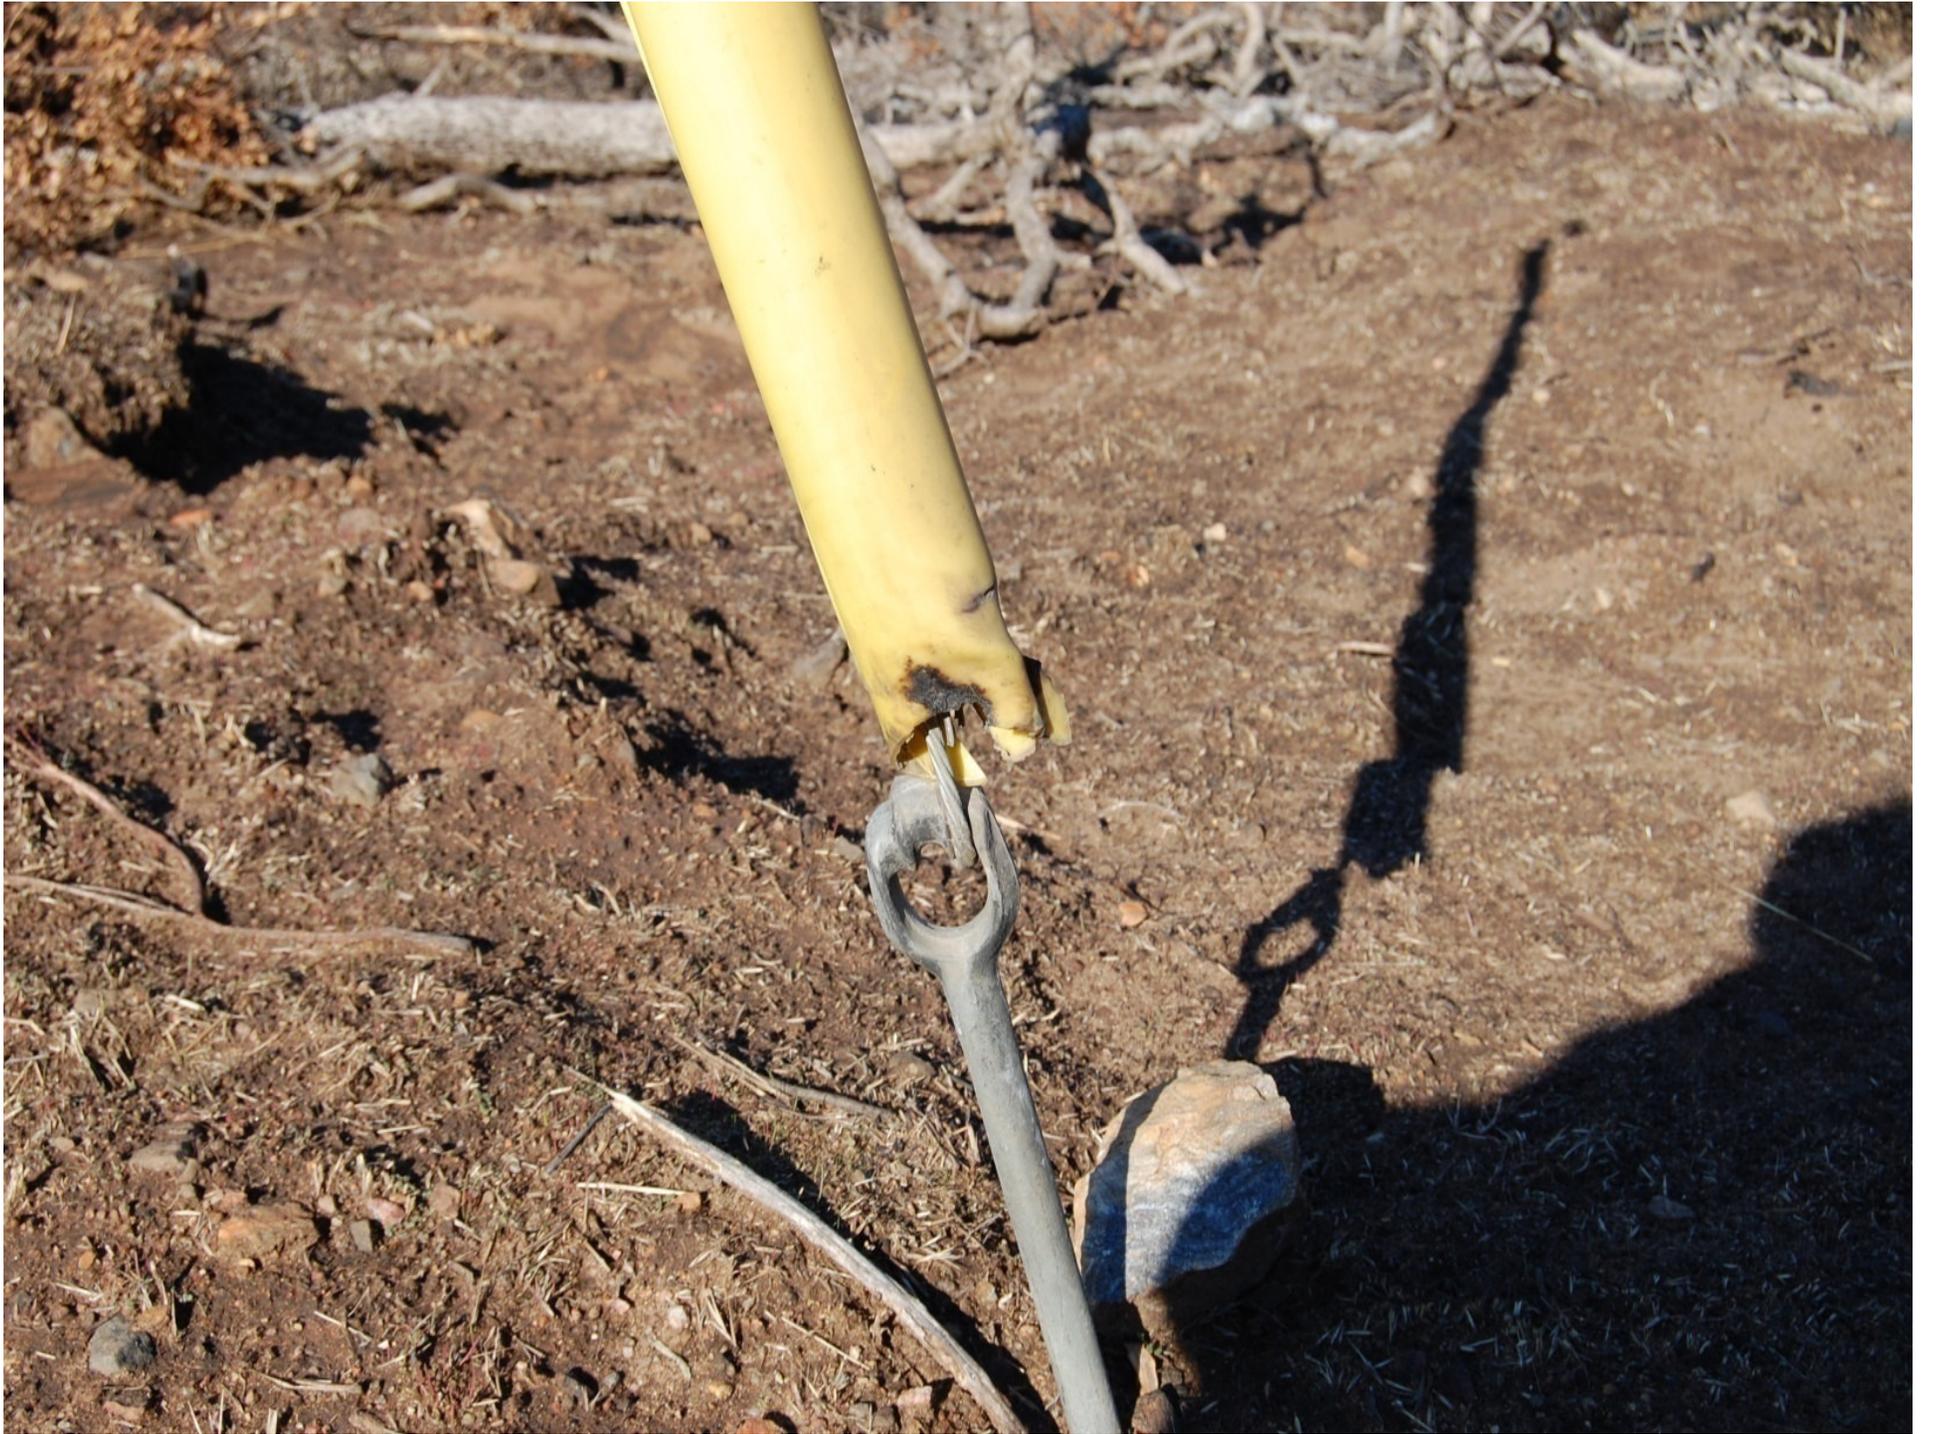
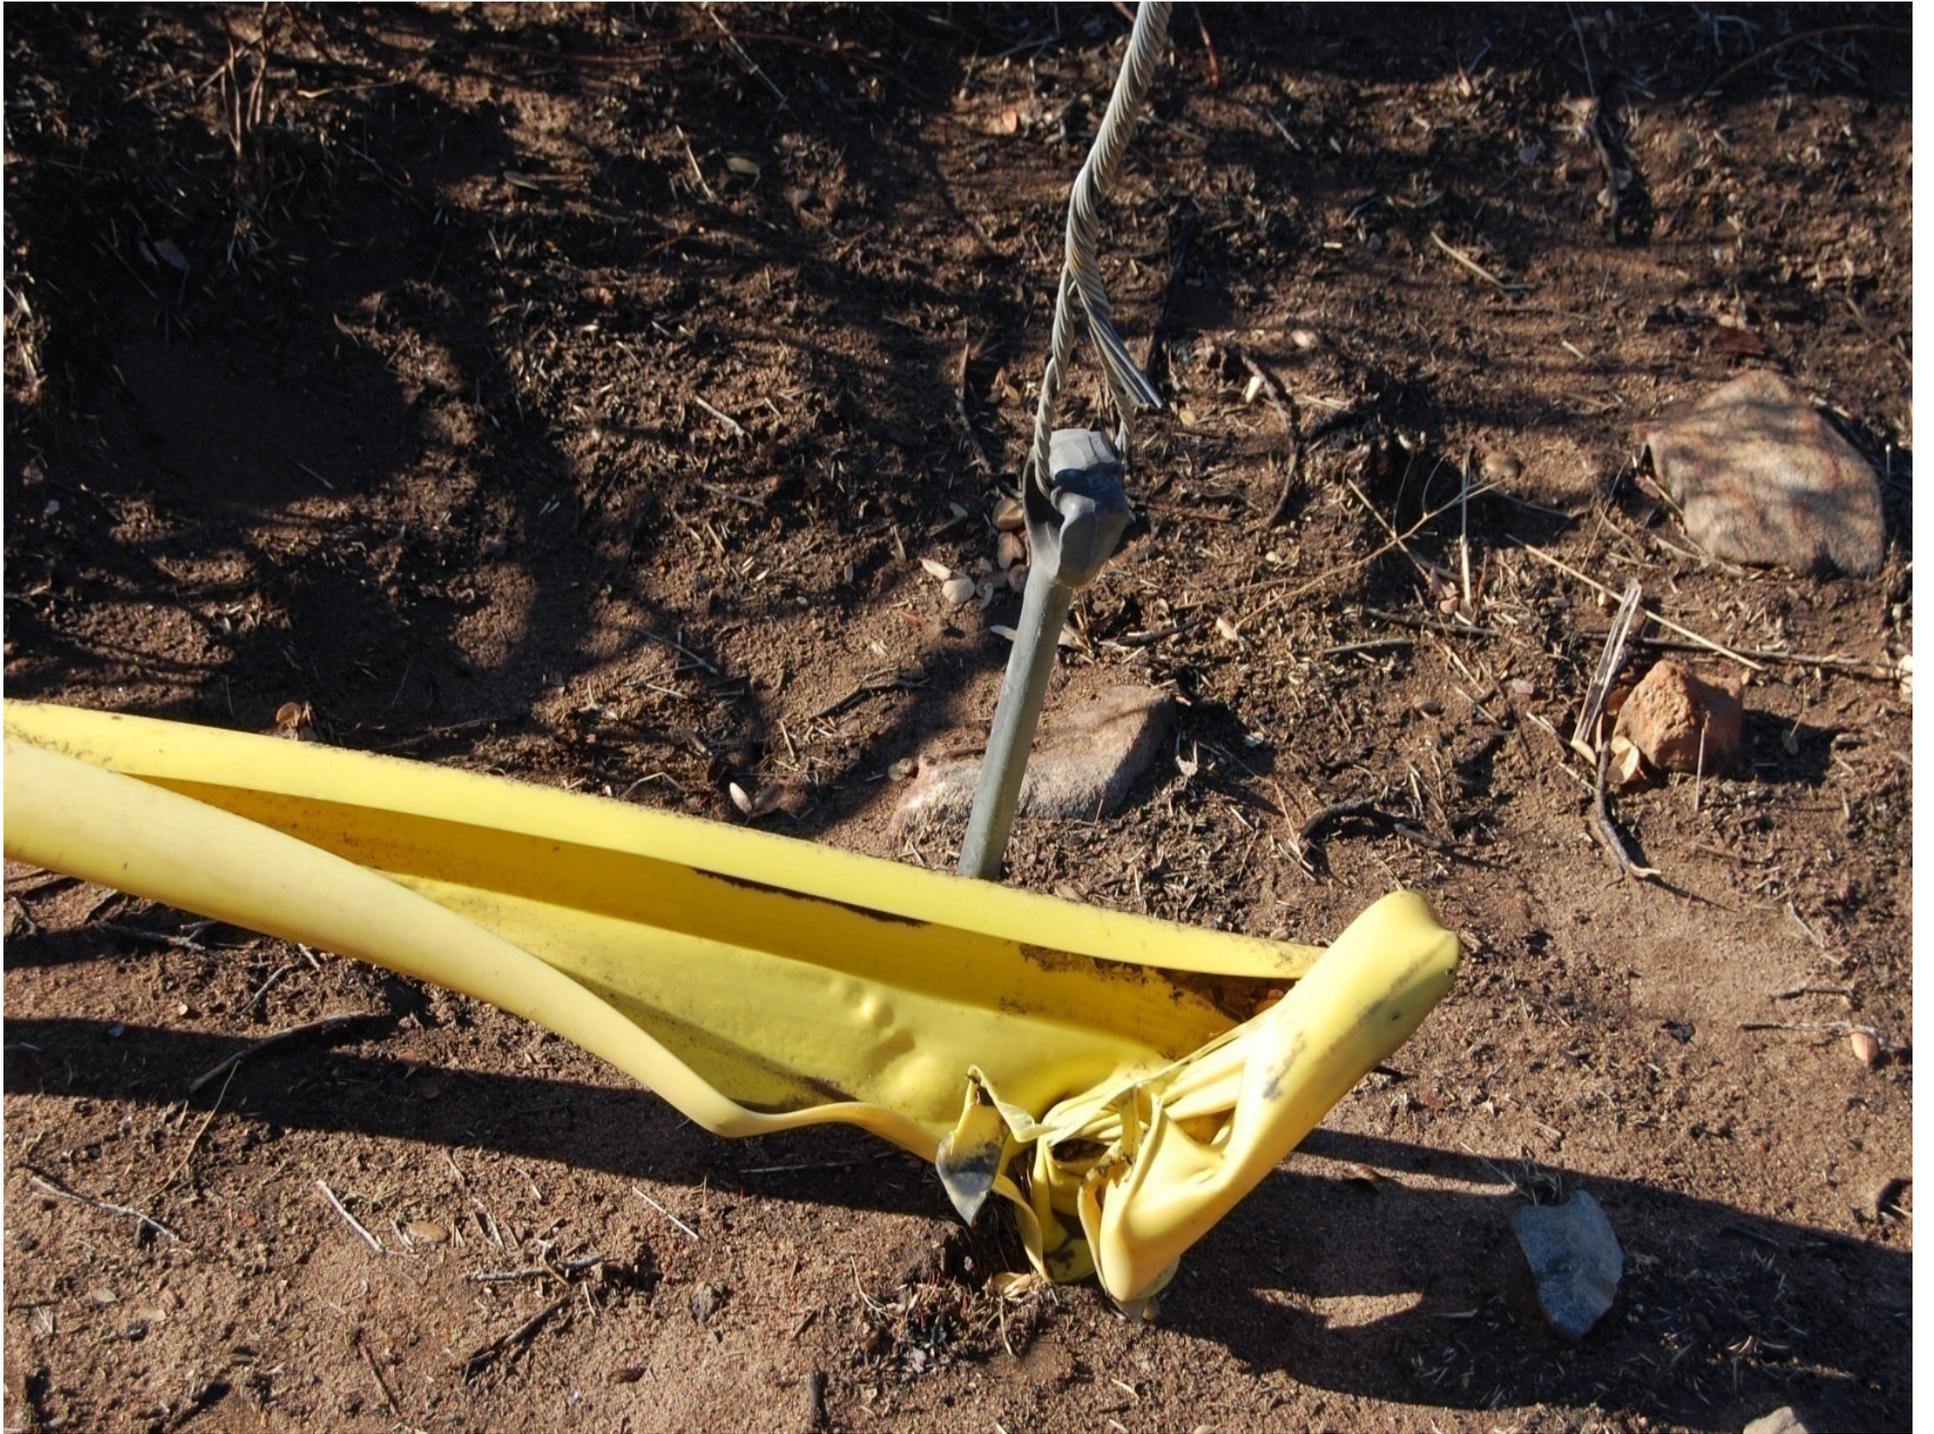
Carbon resulting from Arcing

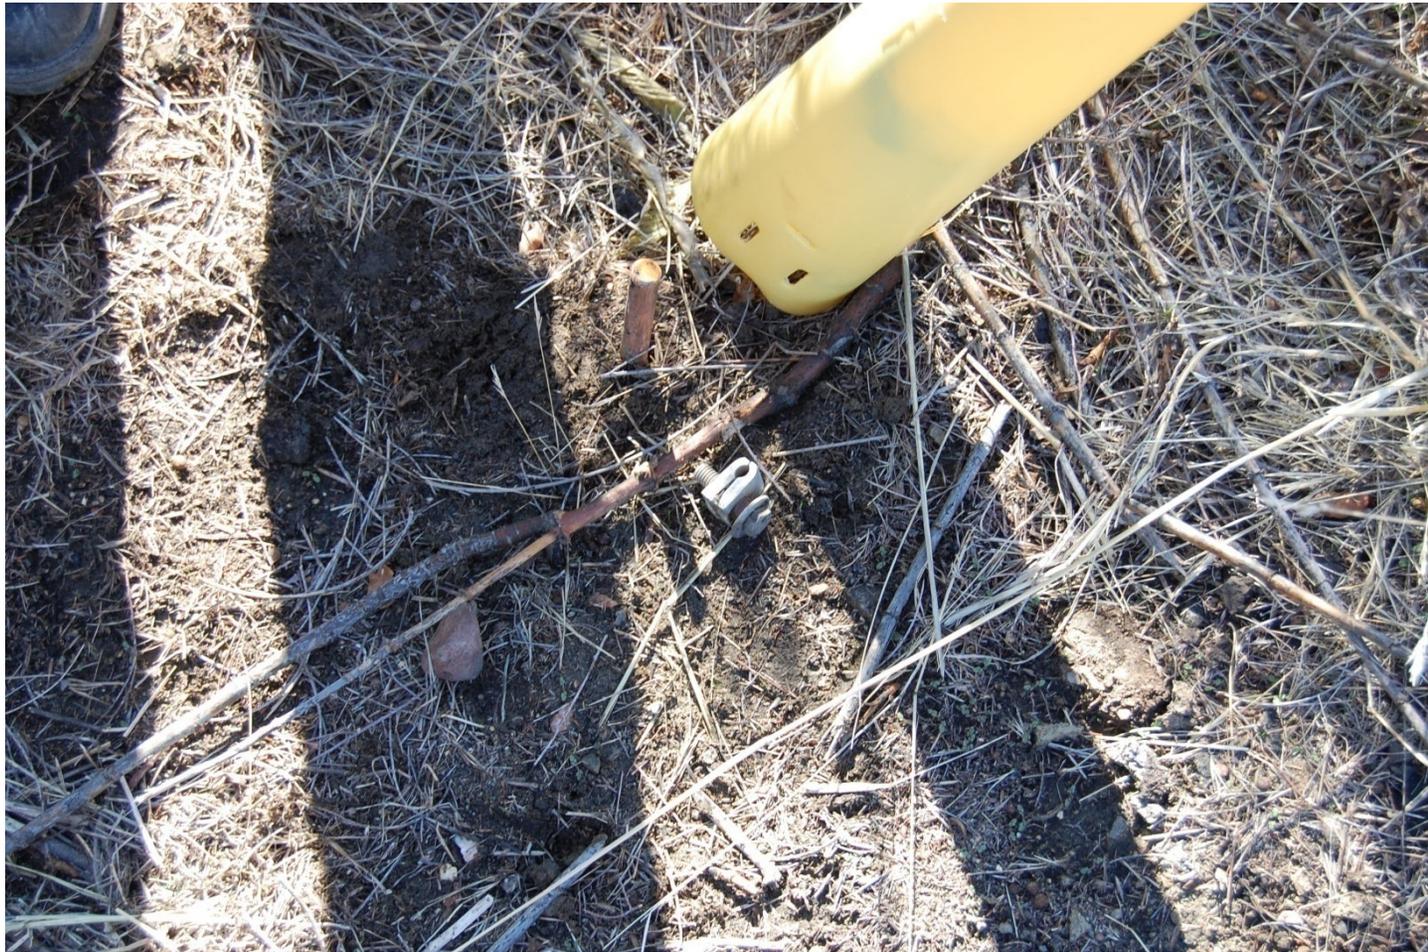
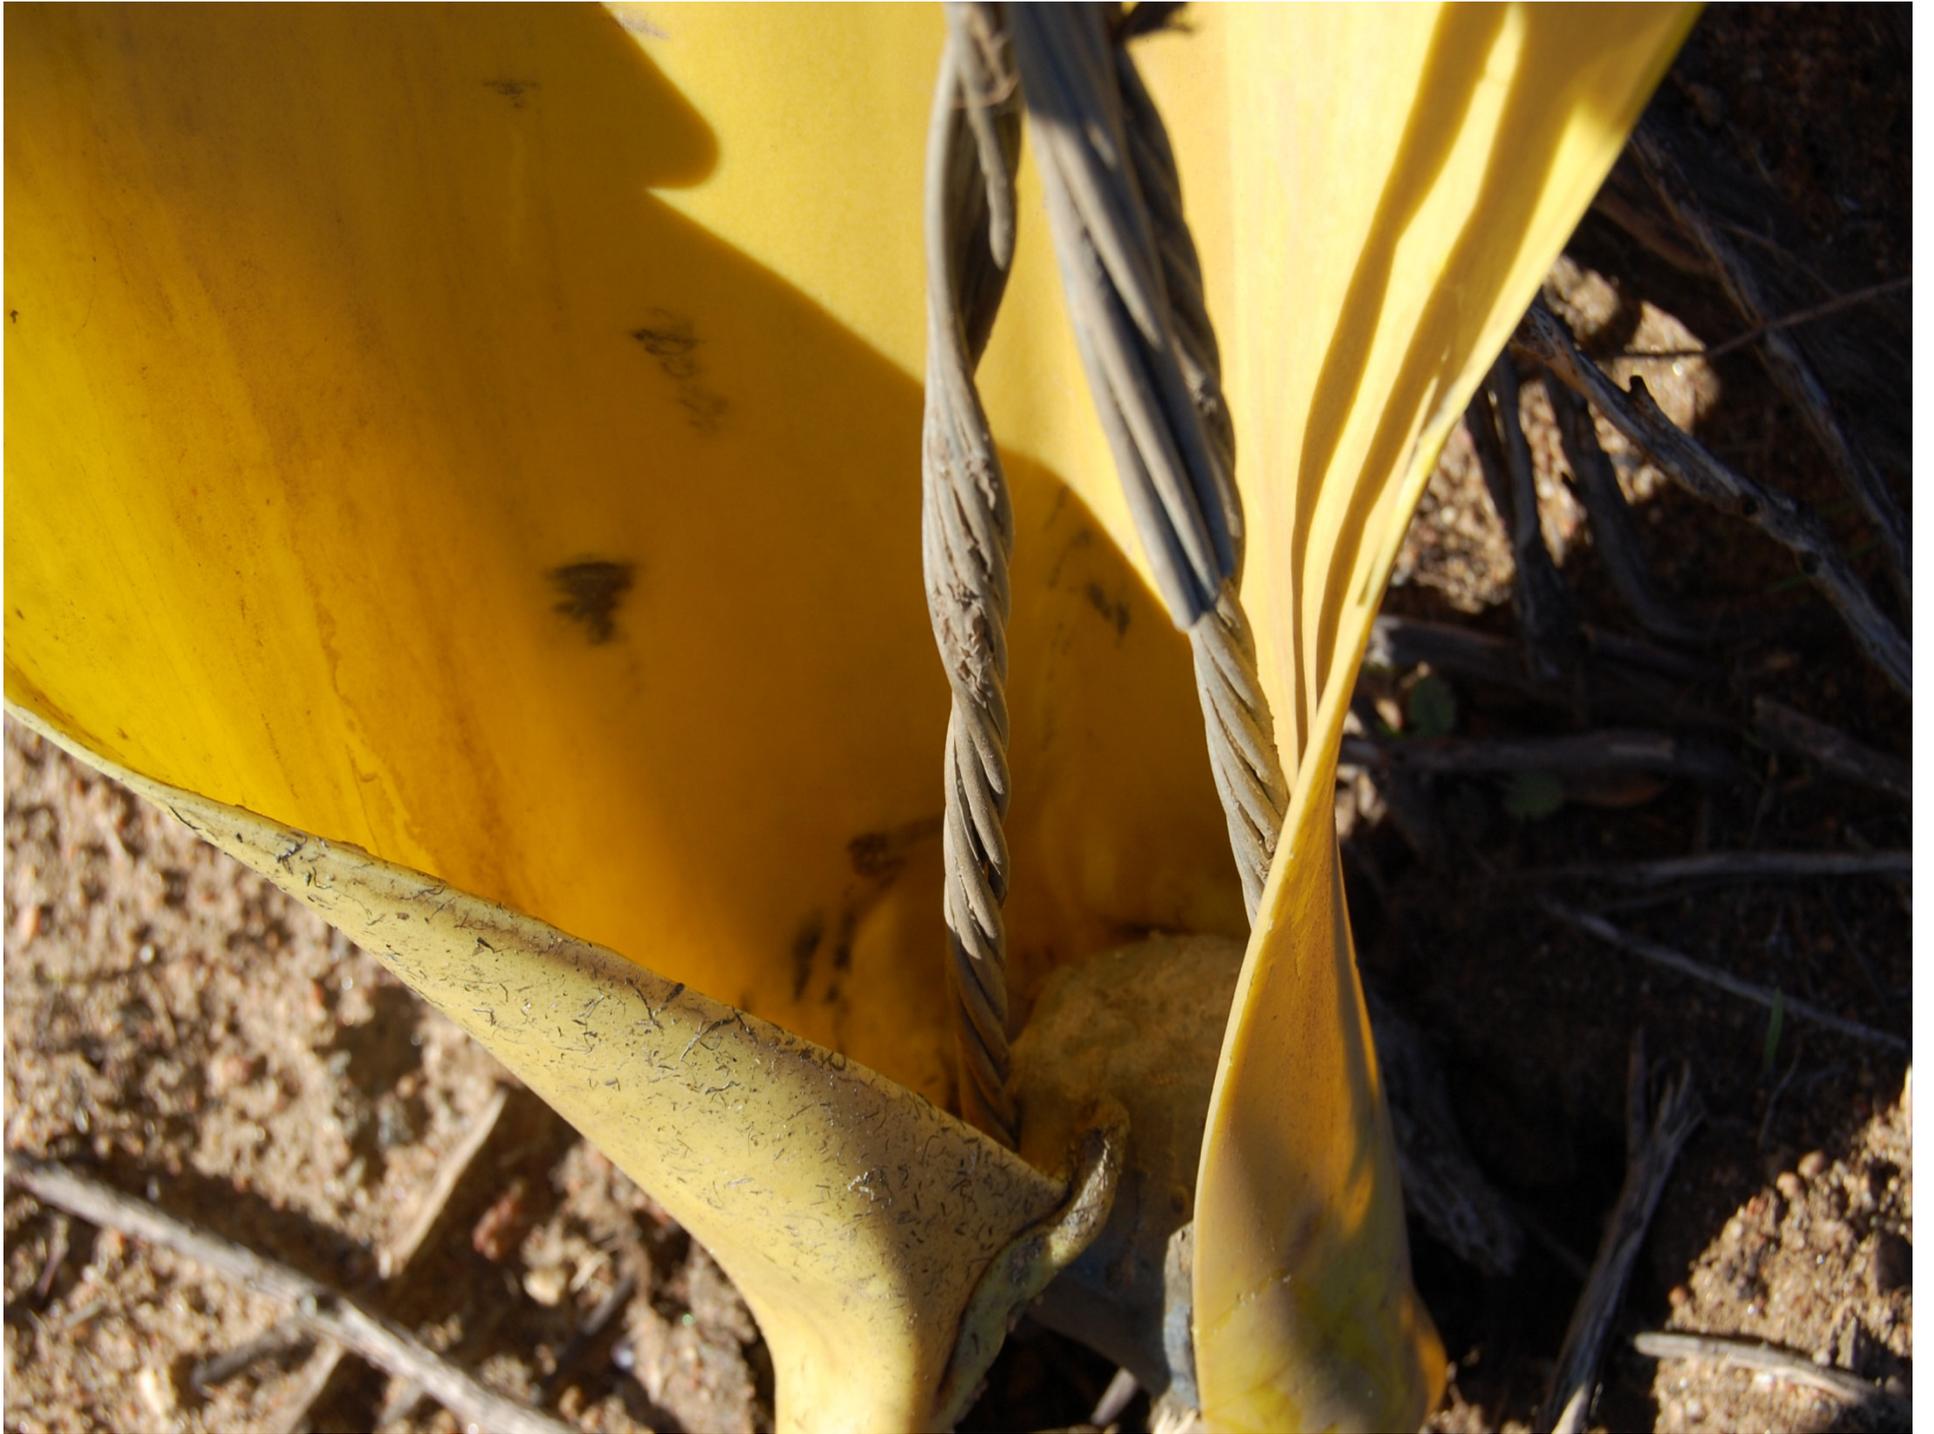
Same down guy construction attached at the same point without vertical clearance or the use of insulators, multiple locations.
