Transmission Line 637
San Diego Gas and Electric
“The Witch Fire 2007”
“The Cedar Fire 2003”

Transmission Line 682
“The Paradise Fire 2003”

Presented by:
Ed Clark
The Electrical Expert
<http://www.TheElectricalExpert.com>

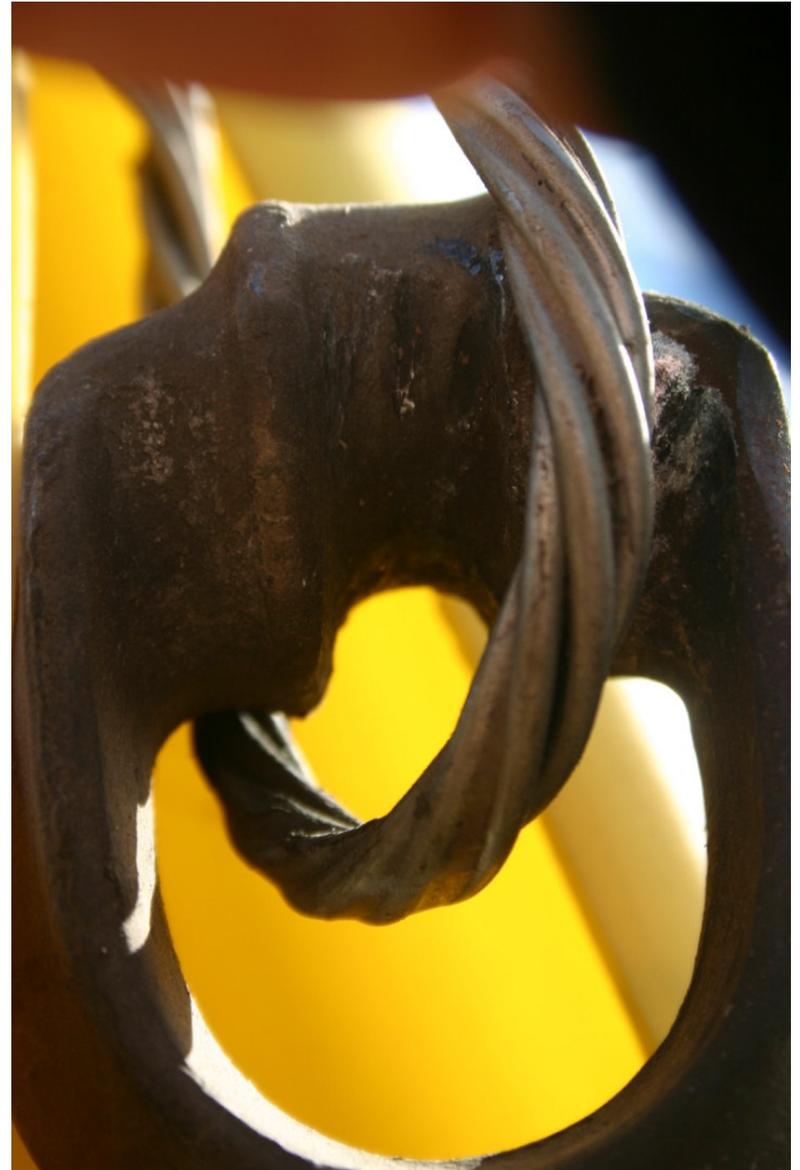
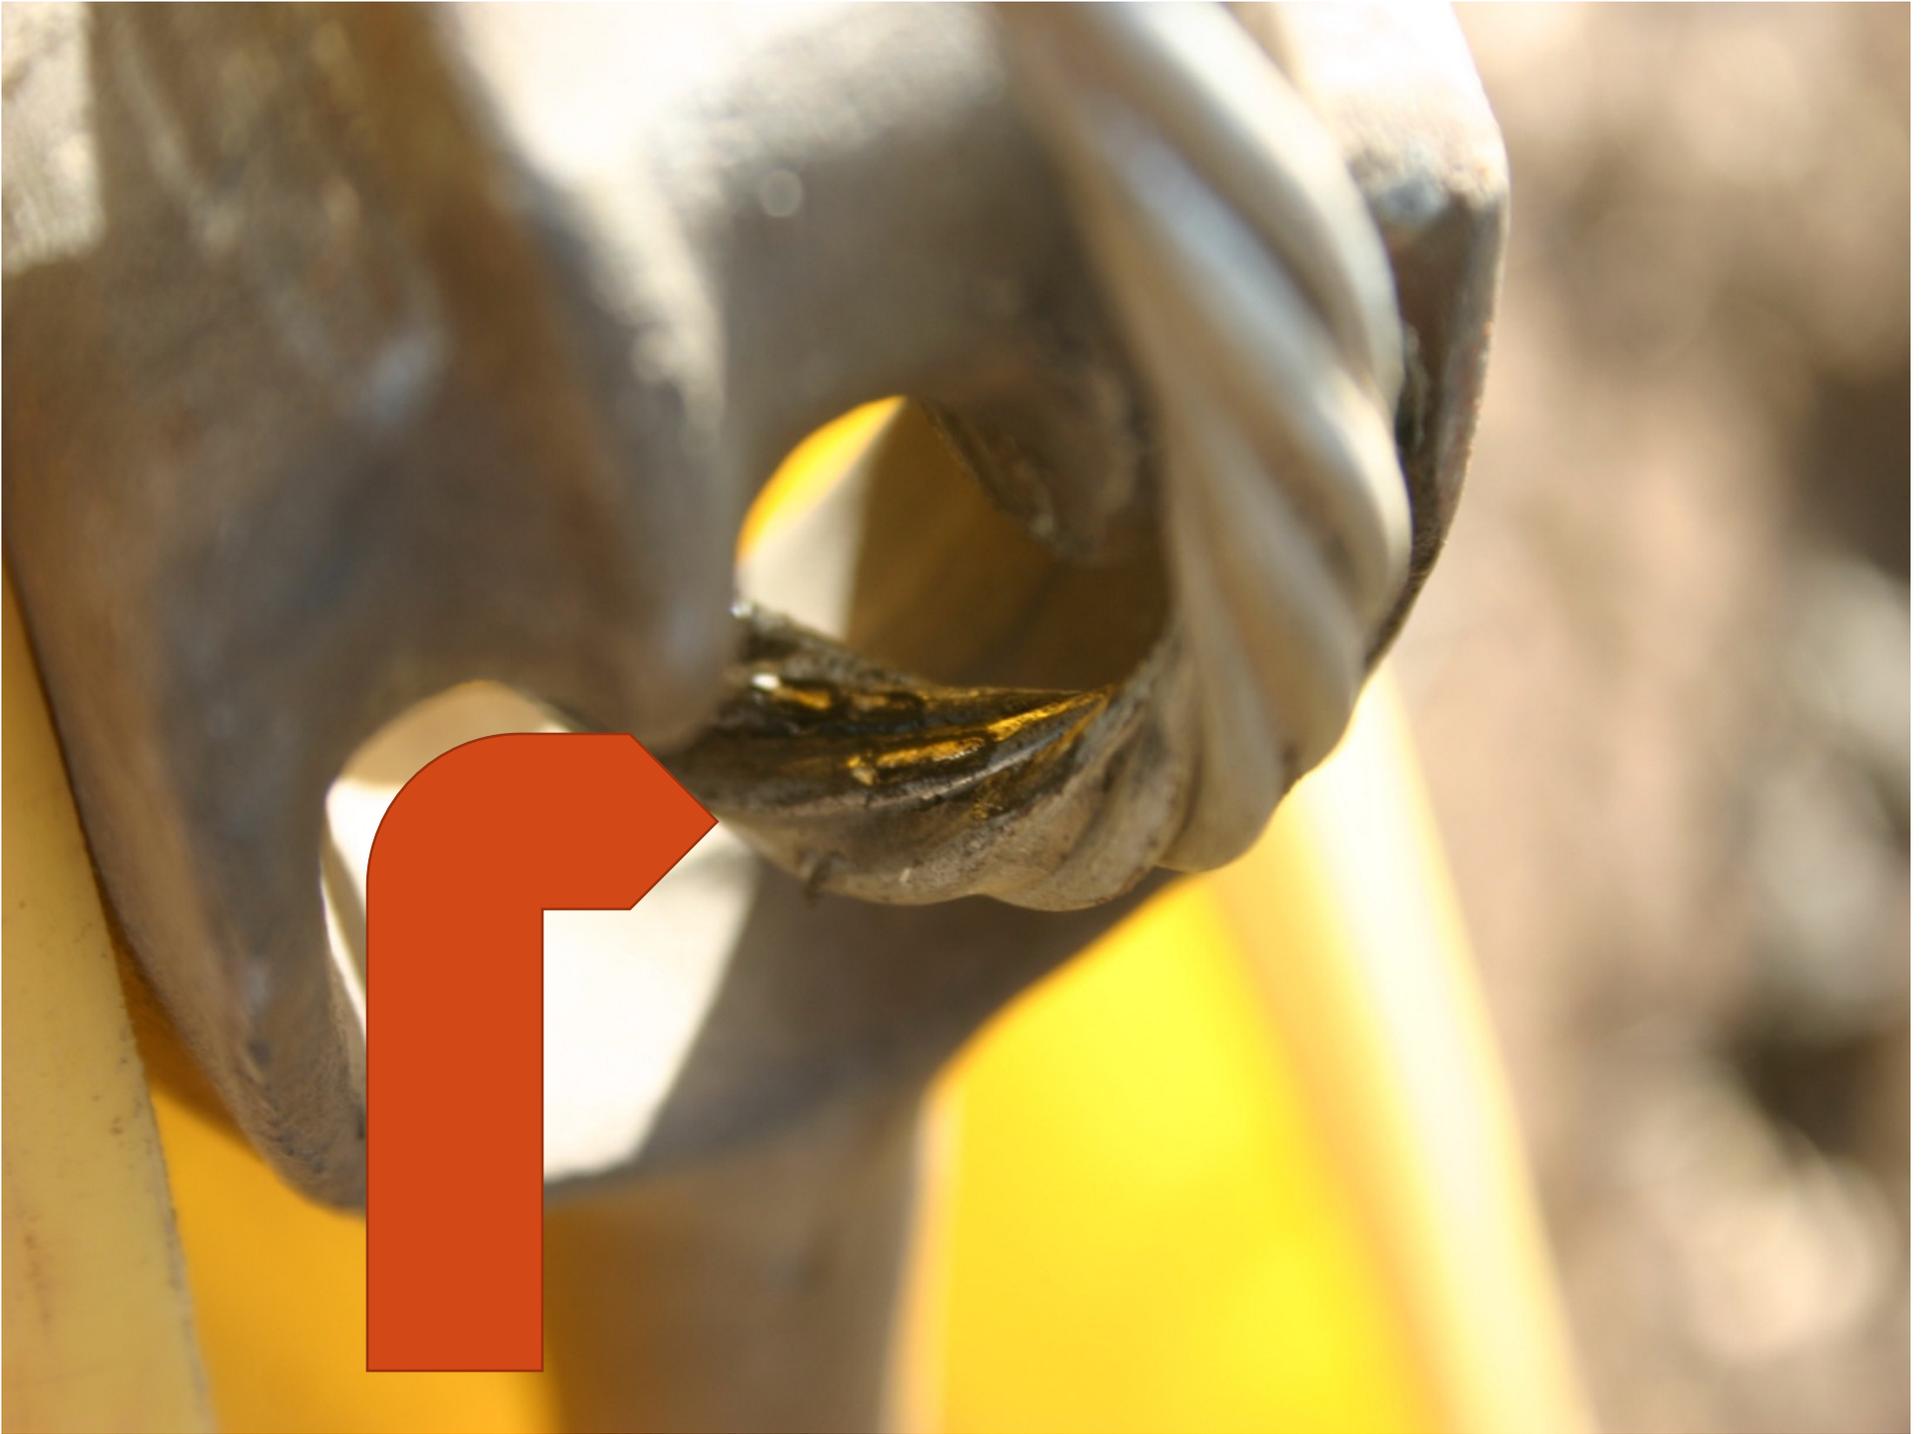
More Arcing

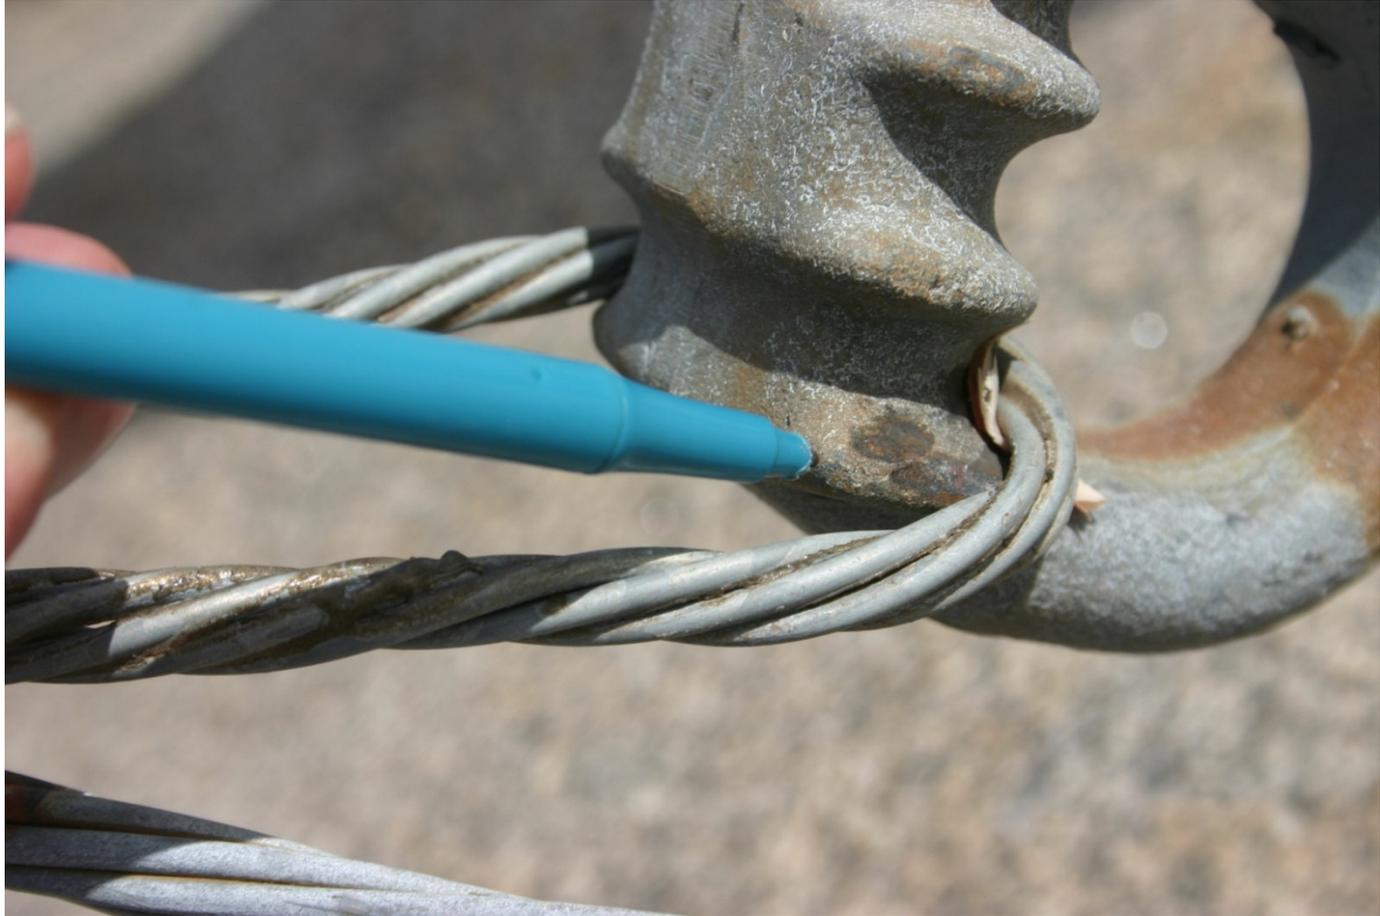
Discoloration from Heat generated by arcing

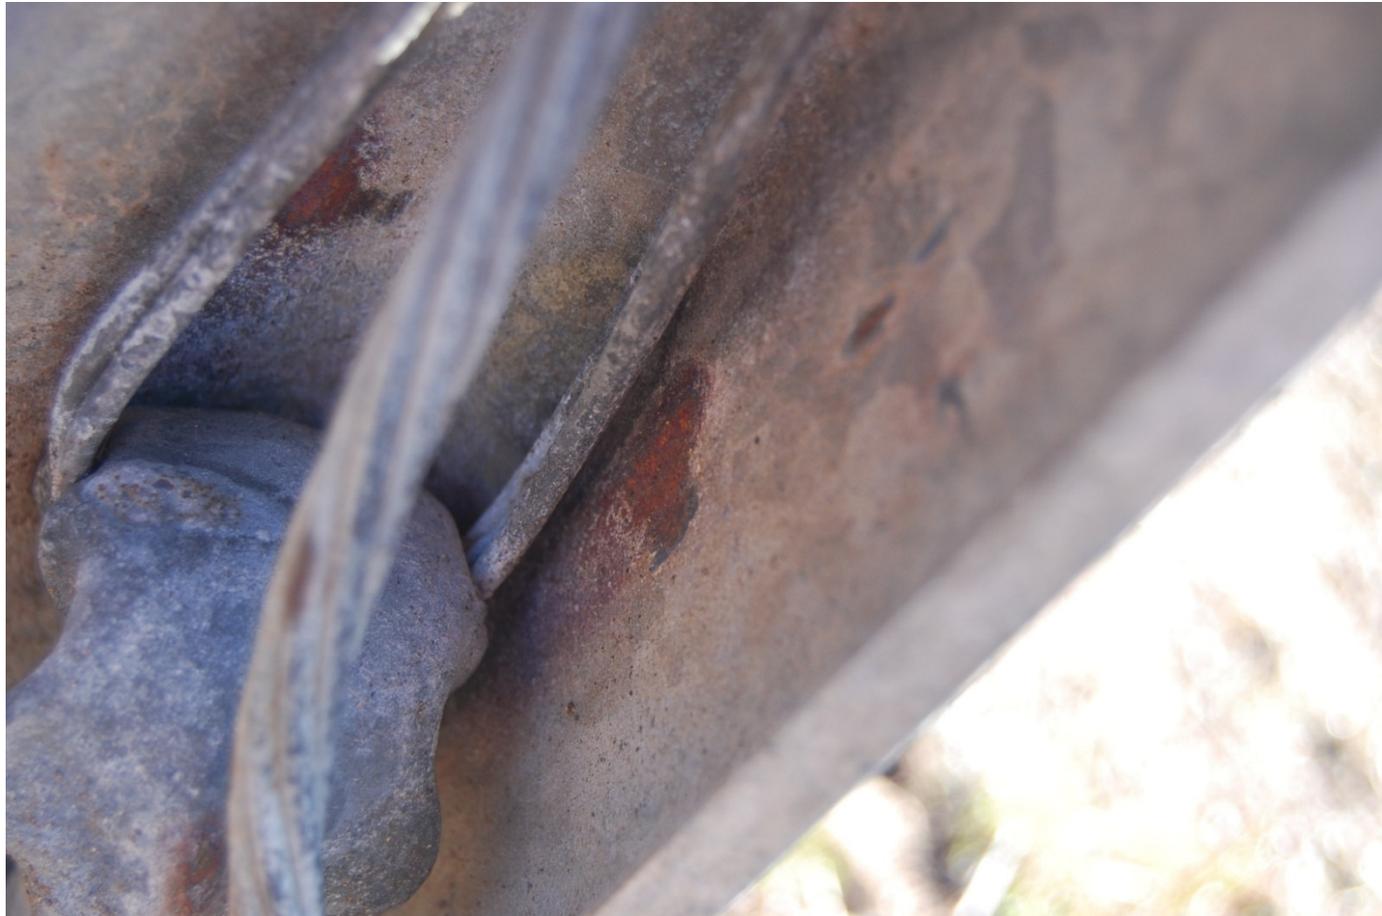
Carbon Build up from Arcing

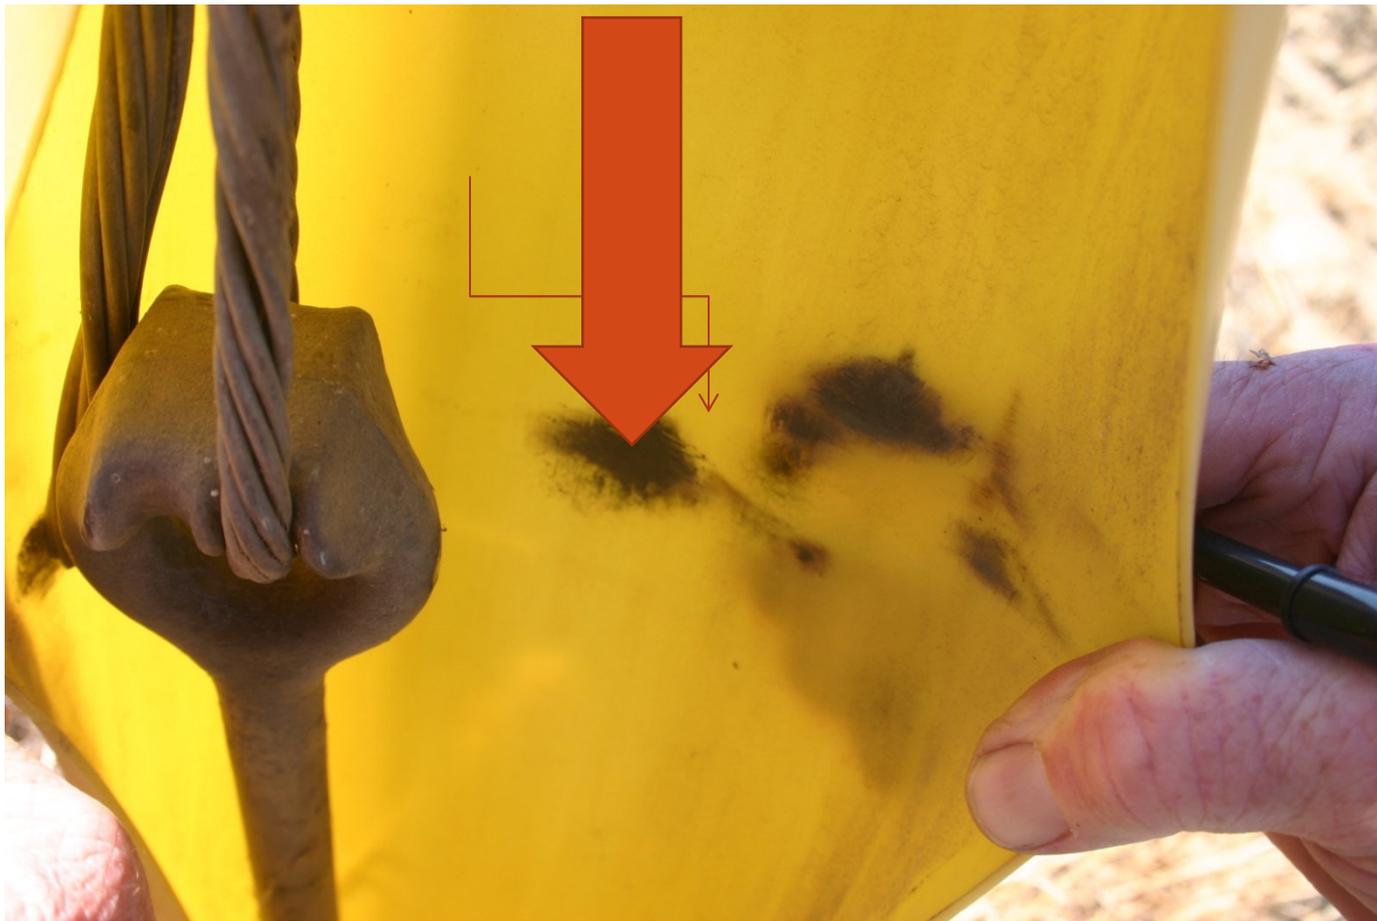
Discoloration From Heat

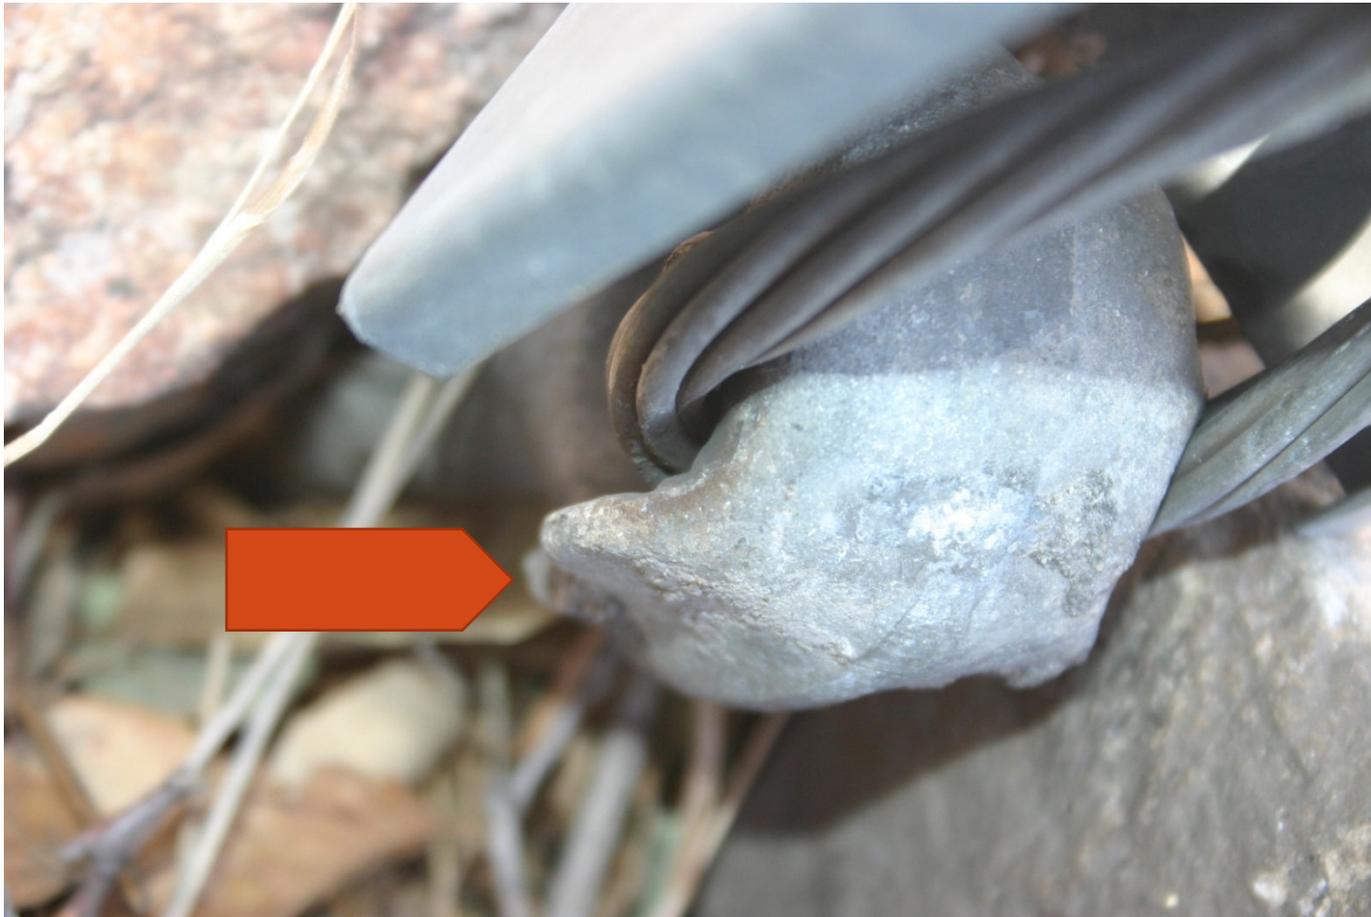
Carbon build up, different type attachment

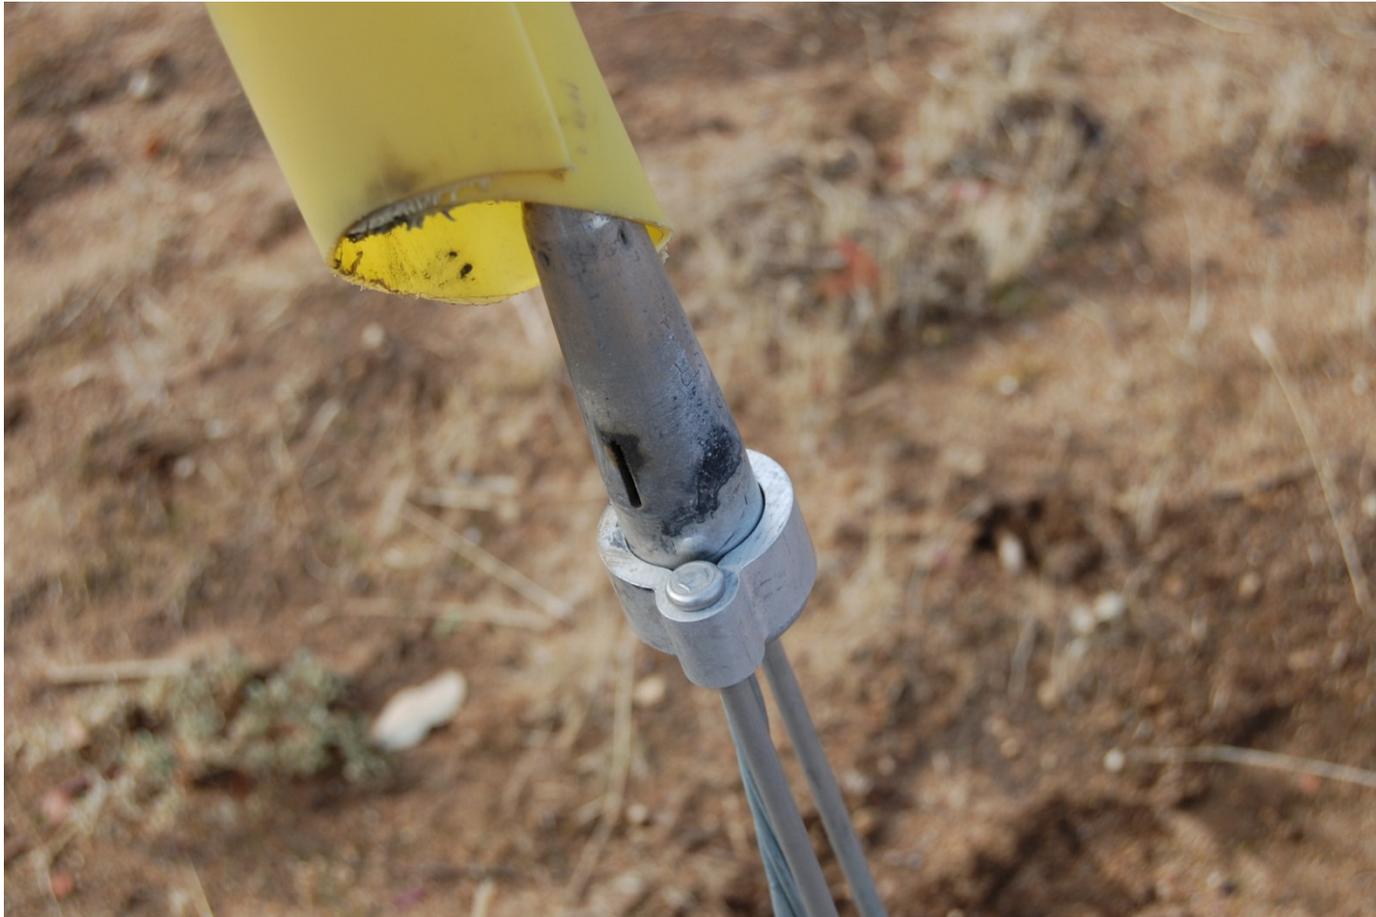
START OF Witch FIRE !!!!

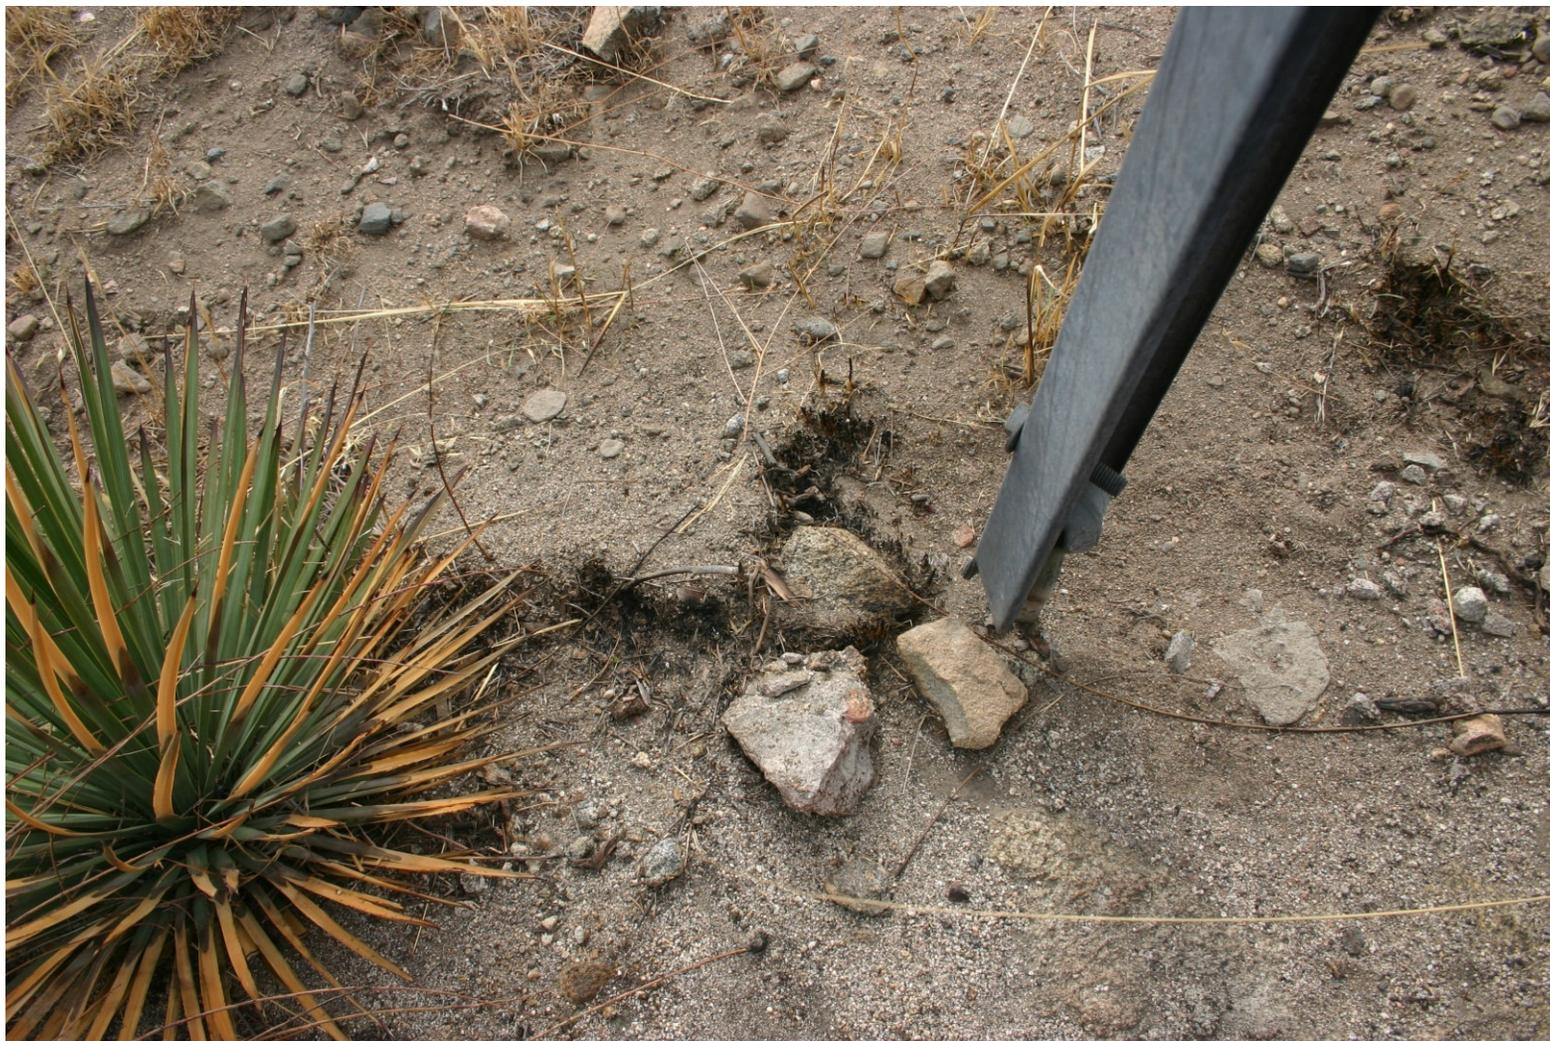
START OF Witch FIRE !!!!

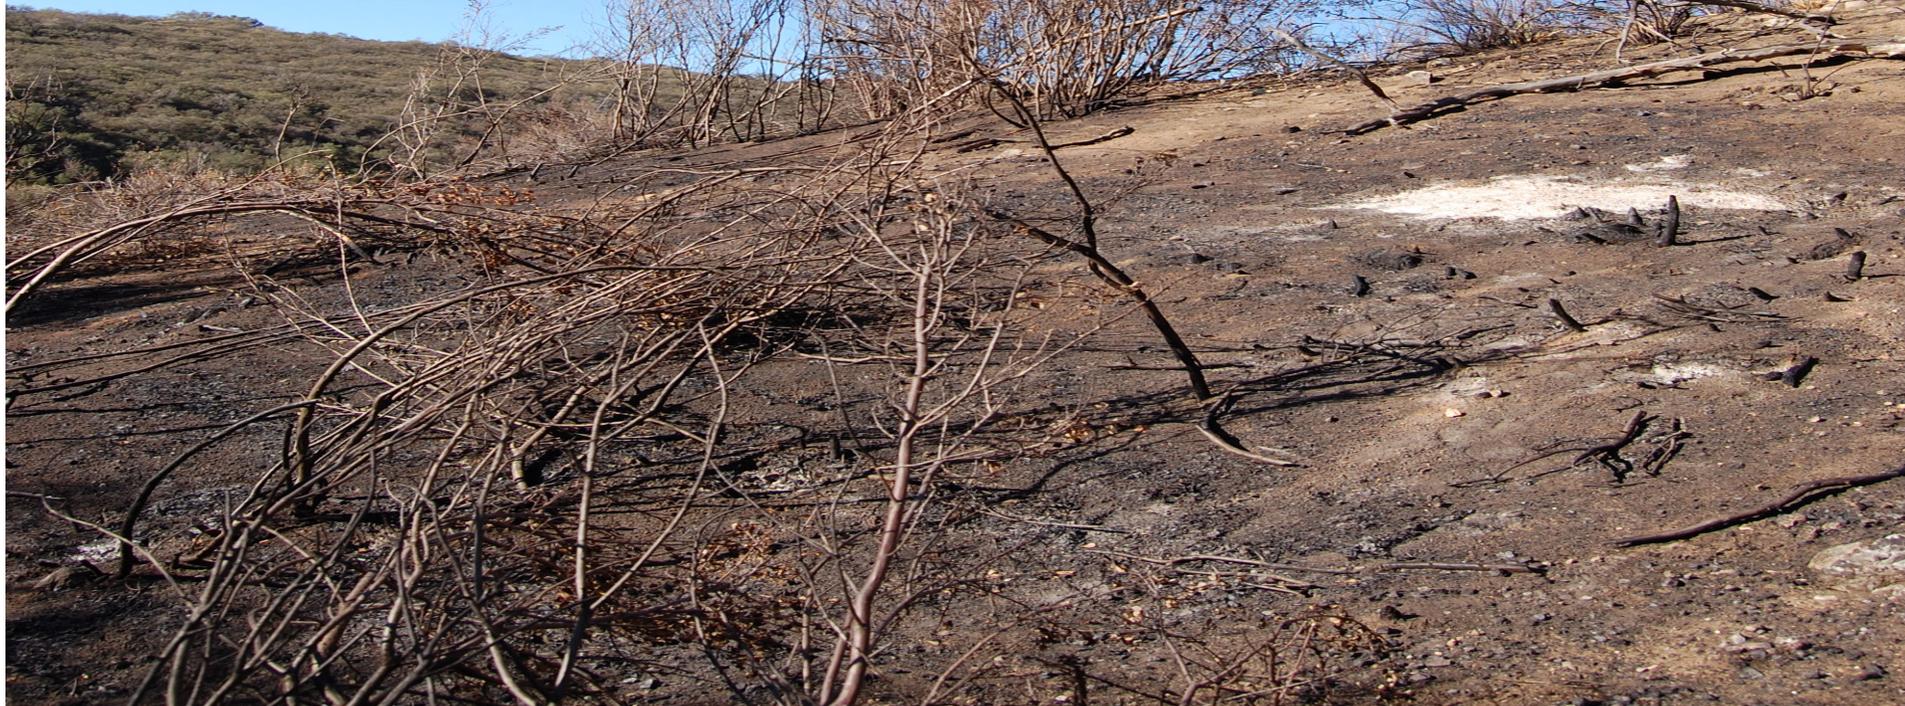
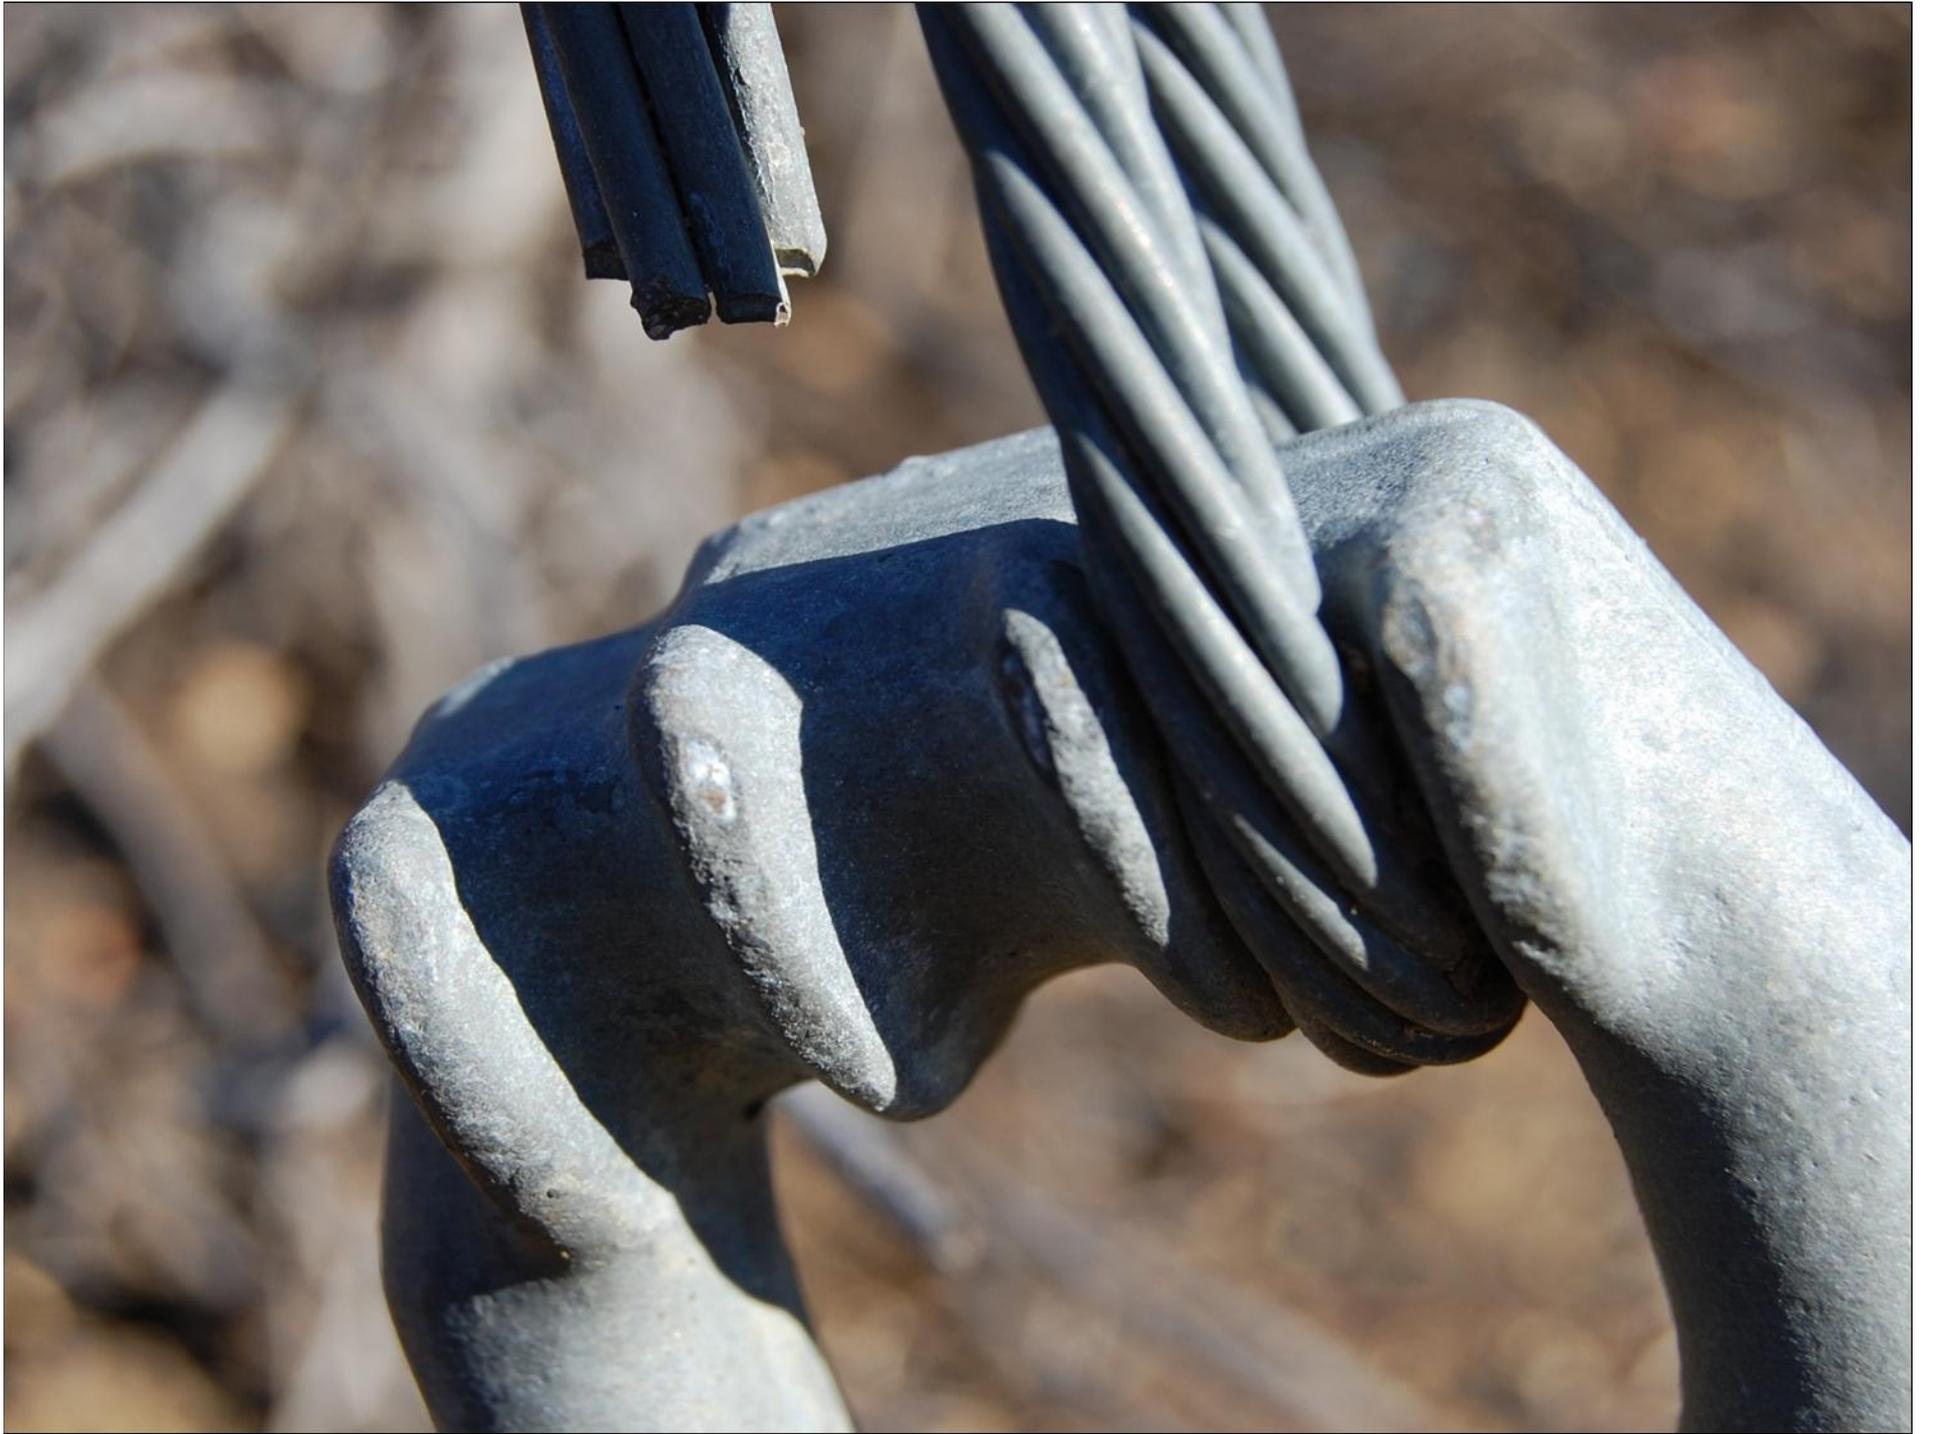
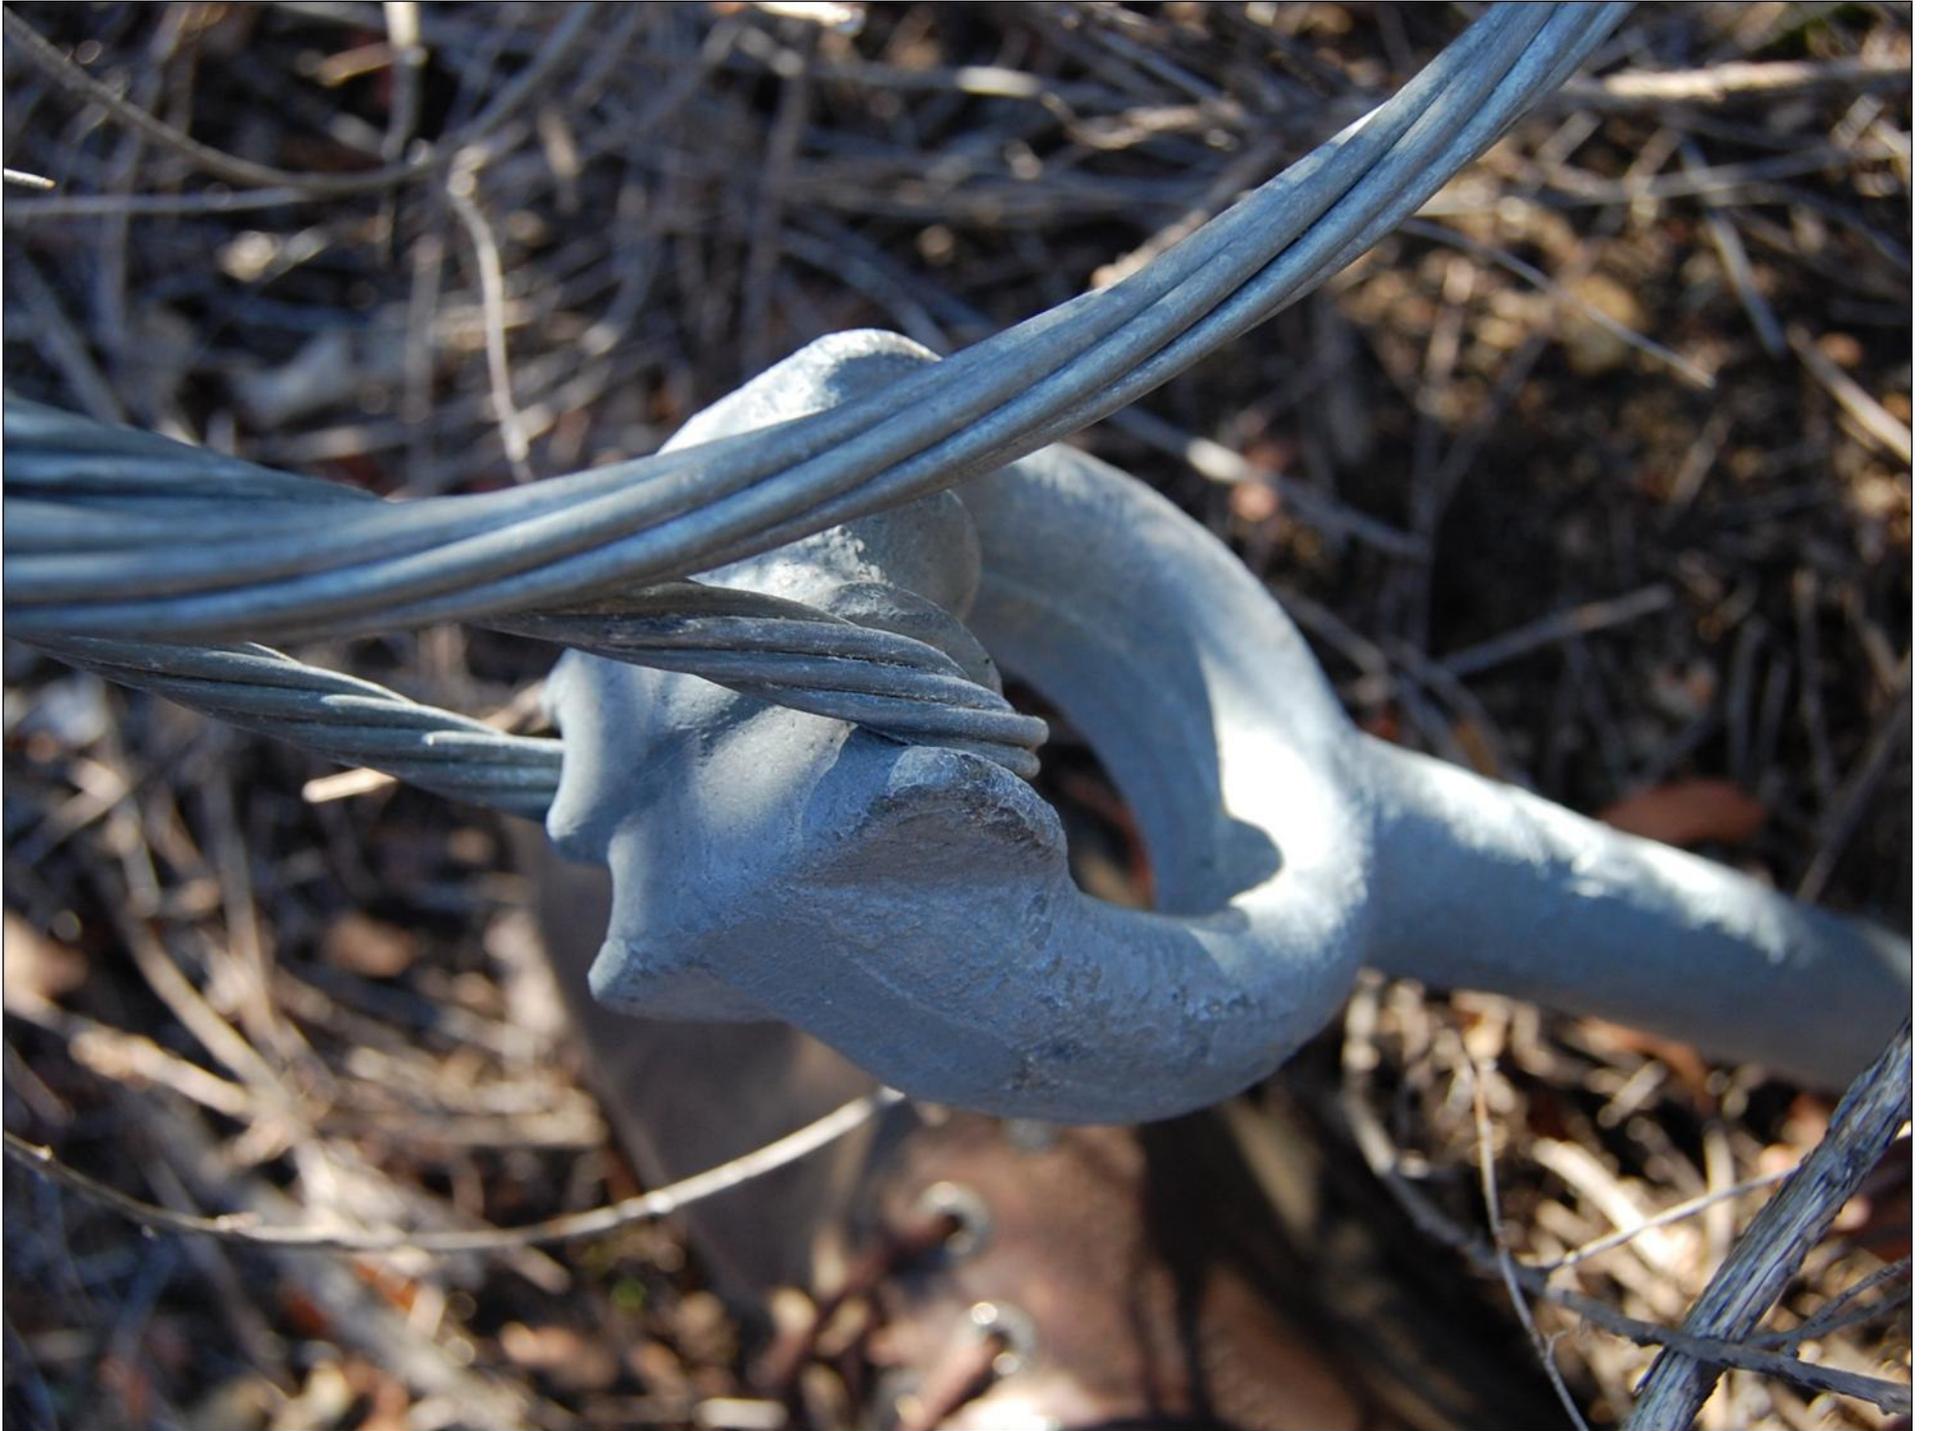
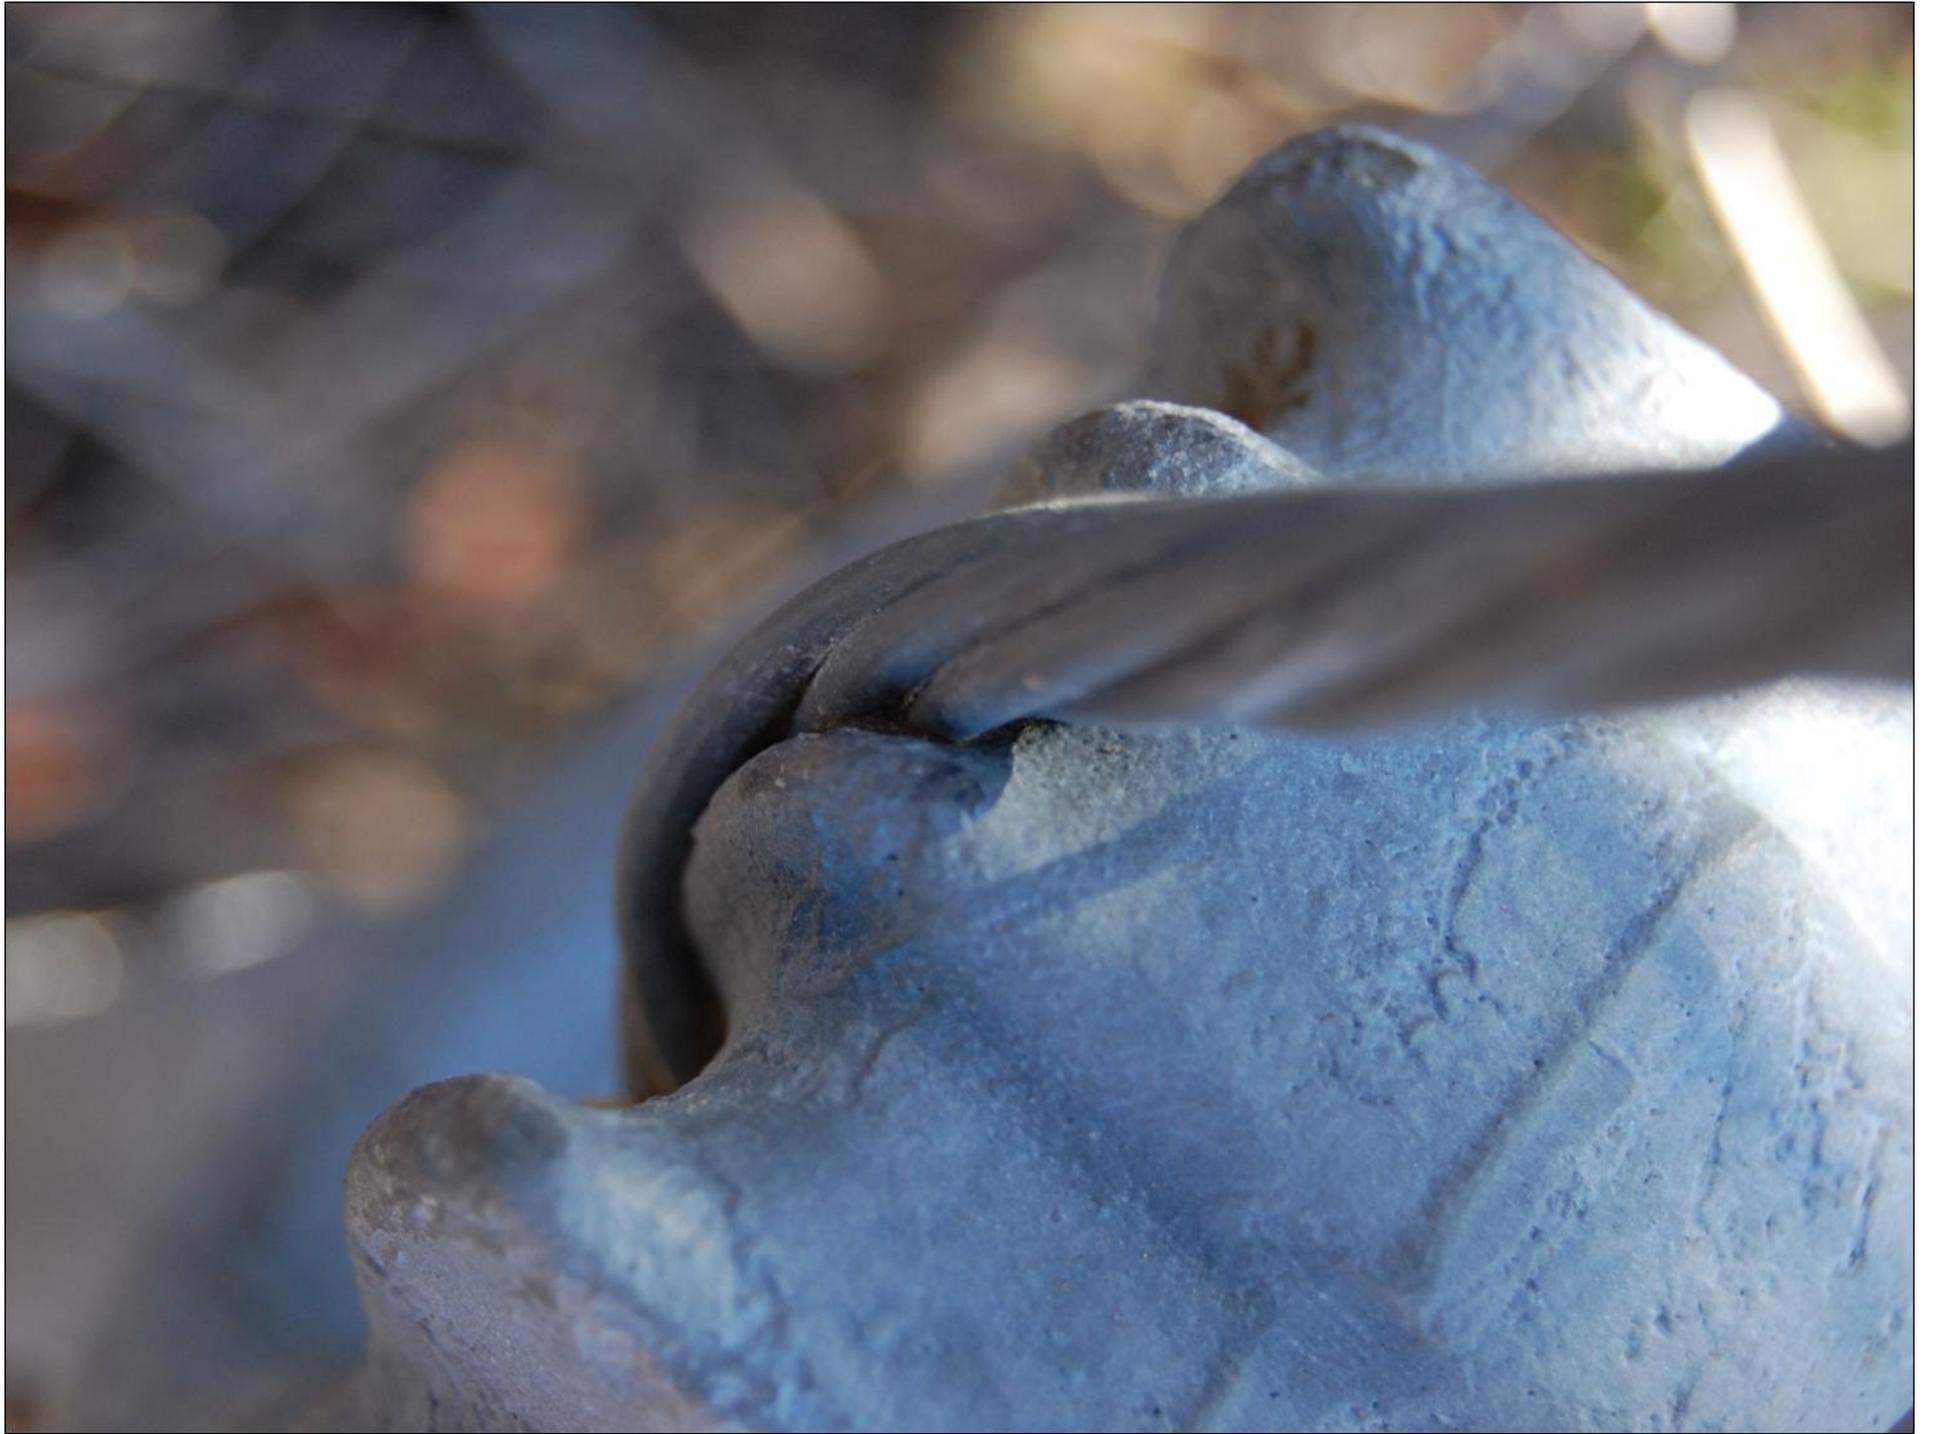
- **Same Problem as Transmission line 637**
- **The Down Guy Construction is a system wide problem.**
 - **Found the start of the Paradise Fire 12/15/07.**
 - **The Cedar Fire overlaps with the Witch Fire.**
- **Pulled samples from poles associated with the Cedar Fire and not the Witch Fire. Positive for Carbon and Arcing.**

- **Treat down guys as hot!**
- **Do not get in series with down guy and anchor while tightening**
- **When separating and adding another point of attachment, utilize shunts while handling: “DO NOT GET IN SERIES WHILE ON POLE!”**
- **Add Insulators on one side or the other when adding new point of attachment to prevent a lineman from grabbing both conductors if climbing the pole.**
