PROPERTY CONDITION REPORT

Client(s): Mr. & Mrs. John Buyers
Property: 23233 Mill Creek Road
Any Town, CA. 99999
Realtor: Ms. Nanci Wiseagent
Date: October 15, 2012
Inspector: Rick DeBoard - Certification #1051
Report #: Sample 30 Year Old House

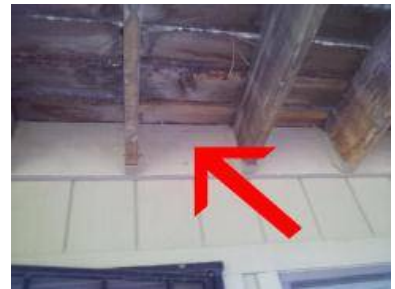
There is no gap between the siding and the deck framing, allowing moisture to get trapped in between these two wood components, often causing eventual deterioration.

Deck ledger boards do not appear to be properly attached to the house with lag bolts, (they are attached with nails only). This may result in the deck pulling away from the house.

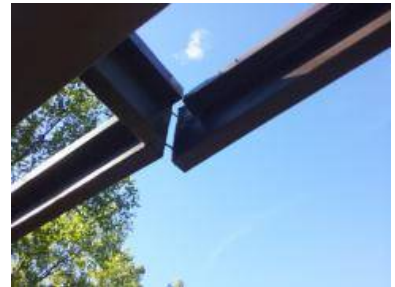
Outside fascia board is loose at two places.

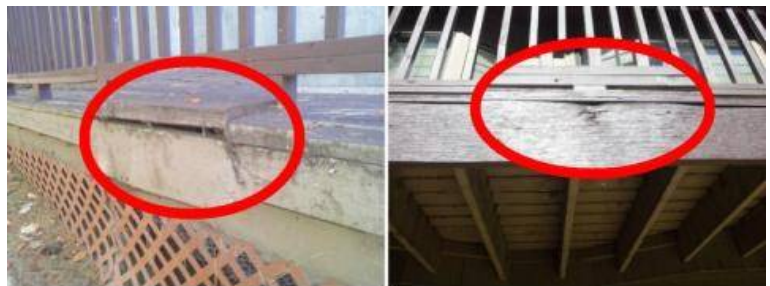
One deck board is loose at the rear of the house, and one outer rim joist is loose and split at the left side of the deck.

One rim joist is deteriorated at one small area at the front the kitchen.

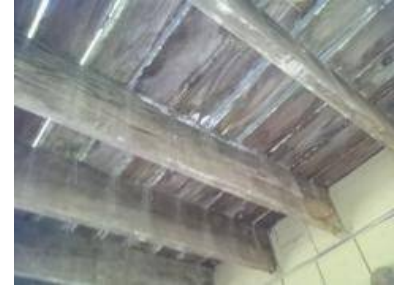
Wood fungus was noted to the surface boards or framing at the underside of the porch. Wood fungus is the first stage of dry rot, and is usually treatable with a fungicide. We recommend that you consult a licensed pest inspection company for information regarding this procedure.

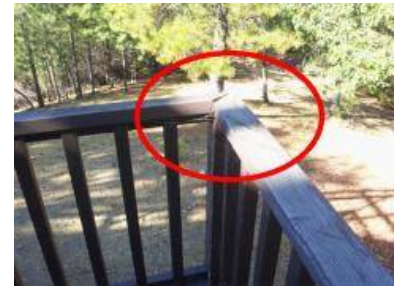
There are places where the top handrails are loose and warped.

Safety Concern - Spacing of railing balusters exceed 4". The standard for older homes was 6", and several years before that it was 9". There is no requirement for upgrading to 4" centers, however, you should be aware that this new standard is to prevent infants from getting their head stuck between the balusters.

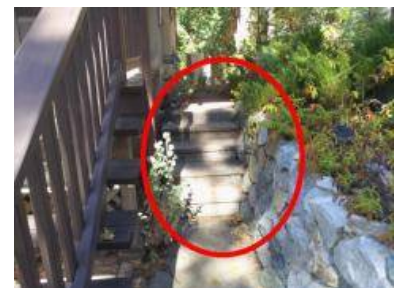
Safety Concern - Handrails are missing at one or both sides of the stairs to the right side of the front entry door.

Handrails are loose at the front stairs.

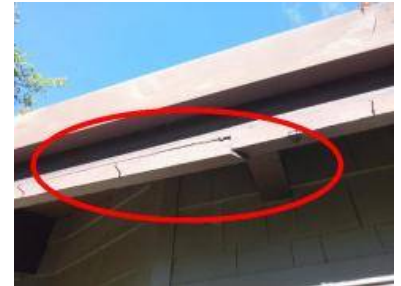
EAVES & OVERHANGS: Fair condition. The fascia board at the eave overhangs is deteriorated at the front of the kitchen.

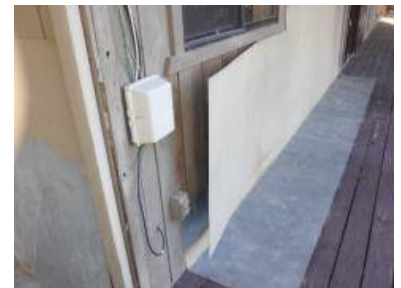
OTHER OBSERVATIONS: The firewood shield is loose from the siding at the left rear corner of the house. This metal is probably to protect wood siding from being infested by wood destroying organisms which live in firewood.

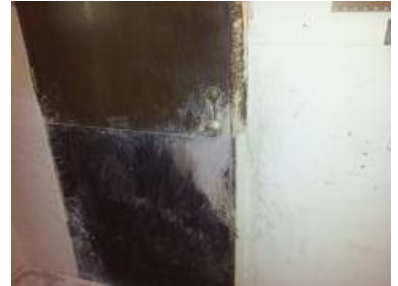
DOOR INTO HOUSE: Fair condition. [The door is damaged.](#)

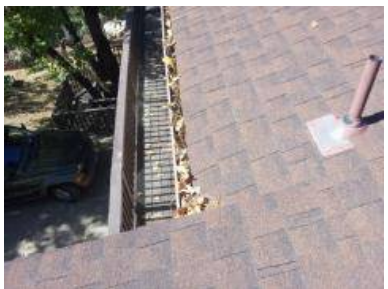
Debris (from overhanging vegetation, mineral deposits from roof shingles, etc.) was noted in the gutters, this is a common condition, however it will accelerate deterioration of gutters. Gutter cleaning is a preventative maintenance procedure which should be performed at least once a year.

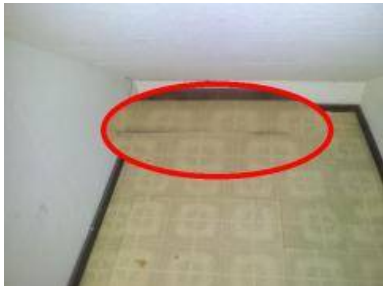
FLOORS, FLOOR COVERINGS: Fair condition. Vinyl. Loose at some seams in the closet.

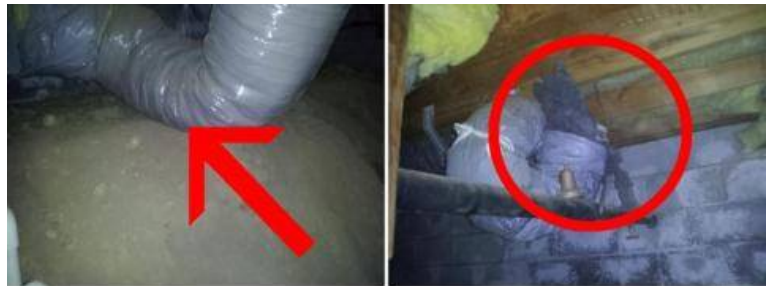
Ducts are disconnected at one place under the kitchen and leaking air into the crawlspace.

The type of tape used is not the currently approved type, (contrary to its name, "duct" tape, or cloth backed tape, is NOT currently approved for connecting furnace ducts as it deteriorates in a relatively short period of time). However, cloth backed tape was allowed at the time that this system was installed. All observable joints were intact at the time of the inspection. If they should come loose in the future we recommend that the repairs be performed with the use of an approved type of HVAC mechanical tape.

We recommend evaluation and repair by a properly qualified HVAC technician.

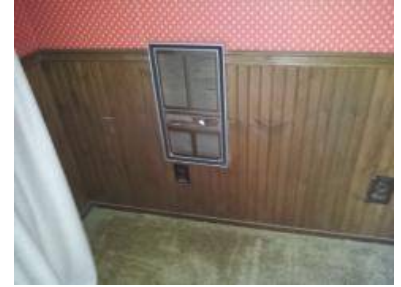
OVERALL CONDITION: Fair to poor condition.
The unit at the master bedroom did not respond to normal operating controls.

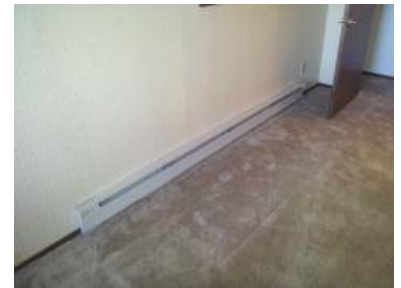
The unit at the downstairs bedroom has no control or thermostat, therefore it is not functioning either. That means that this bedroom has no means of heating.

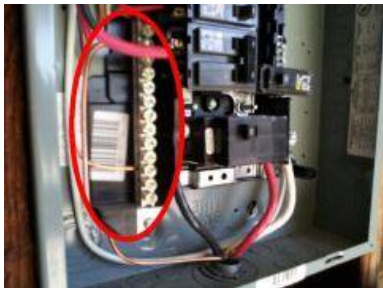
There is no separate grounding busbar, grounding wires are connected to neutral busbar. In a subpanel only the neutral wires should be connected to the neutral busbar, which is isolated from the subpanel housing. The grounding wires should be connected to a separate busbar that is directly grounded to the subpanel housing.

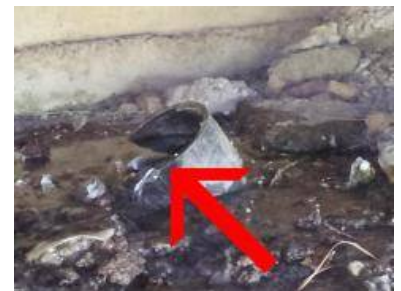
COMMENTS: Cleanouts are provided.
Safety Concern - Open waste line noted at the cleanout under the left side lower deck. There is apparently a major clog in the main underground sewer pipe between the house and the septic tank, as water was running out of this cleanout (the one reference above), during the time of our inspection. On properties such as this which have been vacant for a period of time we run multiple fixtures for an hour or more during our inspection just for this reason (to see if there are underground clogs that we might not otherwise discover.)

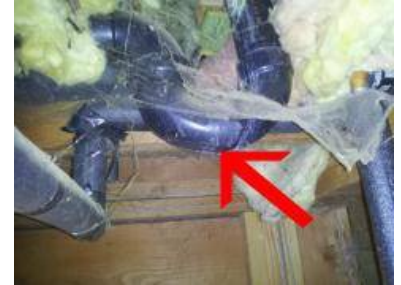
Waste line leaks which are visible from under the house (in the underfloor crawlspace) were noted at the master bathroom shower drain.

The garage sink drains slow.

We recommend further evaluation be performed by a properly qualified plumber.

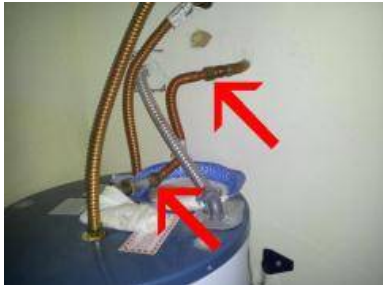
CONDITION: This unit is currently leaking at two different places in the drainline of the safety relief valve.

This water heater appears to be at or near the end of its useful life, as we ran it for more than an hour and it only produced water that was luke warm.

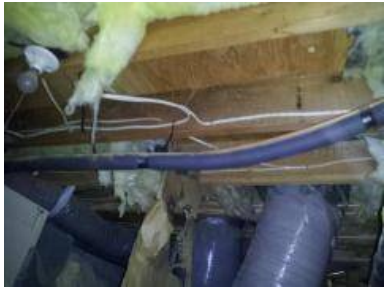
- SUBFLOOR:** Underfloor areas which are insulated are not visible for inspection. Good condition where visible. Plywood.
- PONY AND SHEAR WALLS:** Good condition.
- FLOOR INSULATION:** Fair condition. Partially insulated with R-11 - R-19. Insulation is hanging down and missing in some places.
