Transmission Line 637
San Diego Gas and Electric
“The Witch Fire 2007”
“The Cedar Fire 2003”

Transmission Line 682
“The Paradise Fire 2003”

Presented by:
Ed Clark
The Electrical Expert
<http://www.TheElectricalExpert.com>

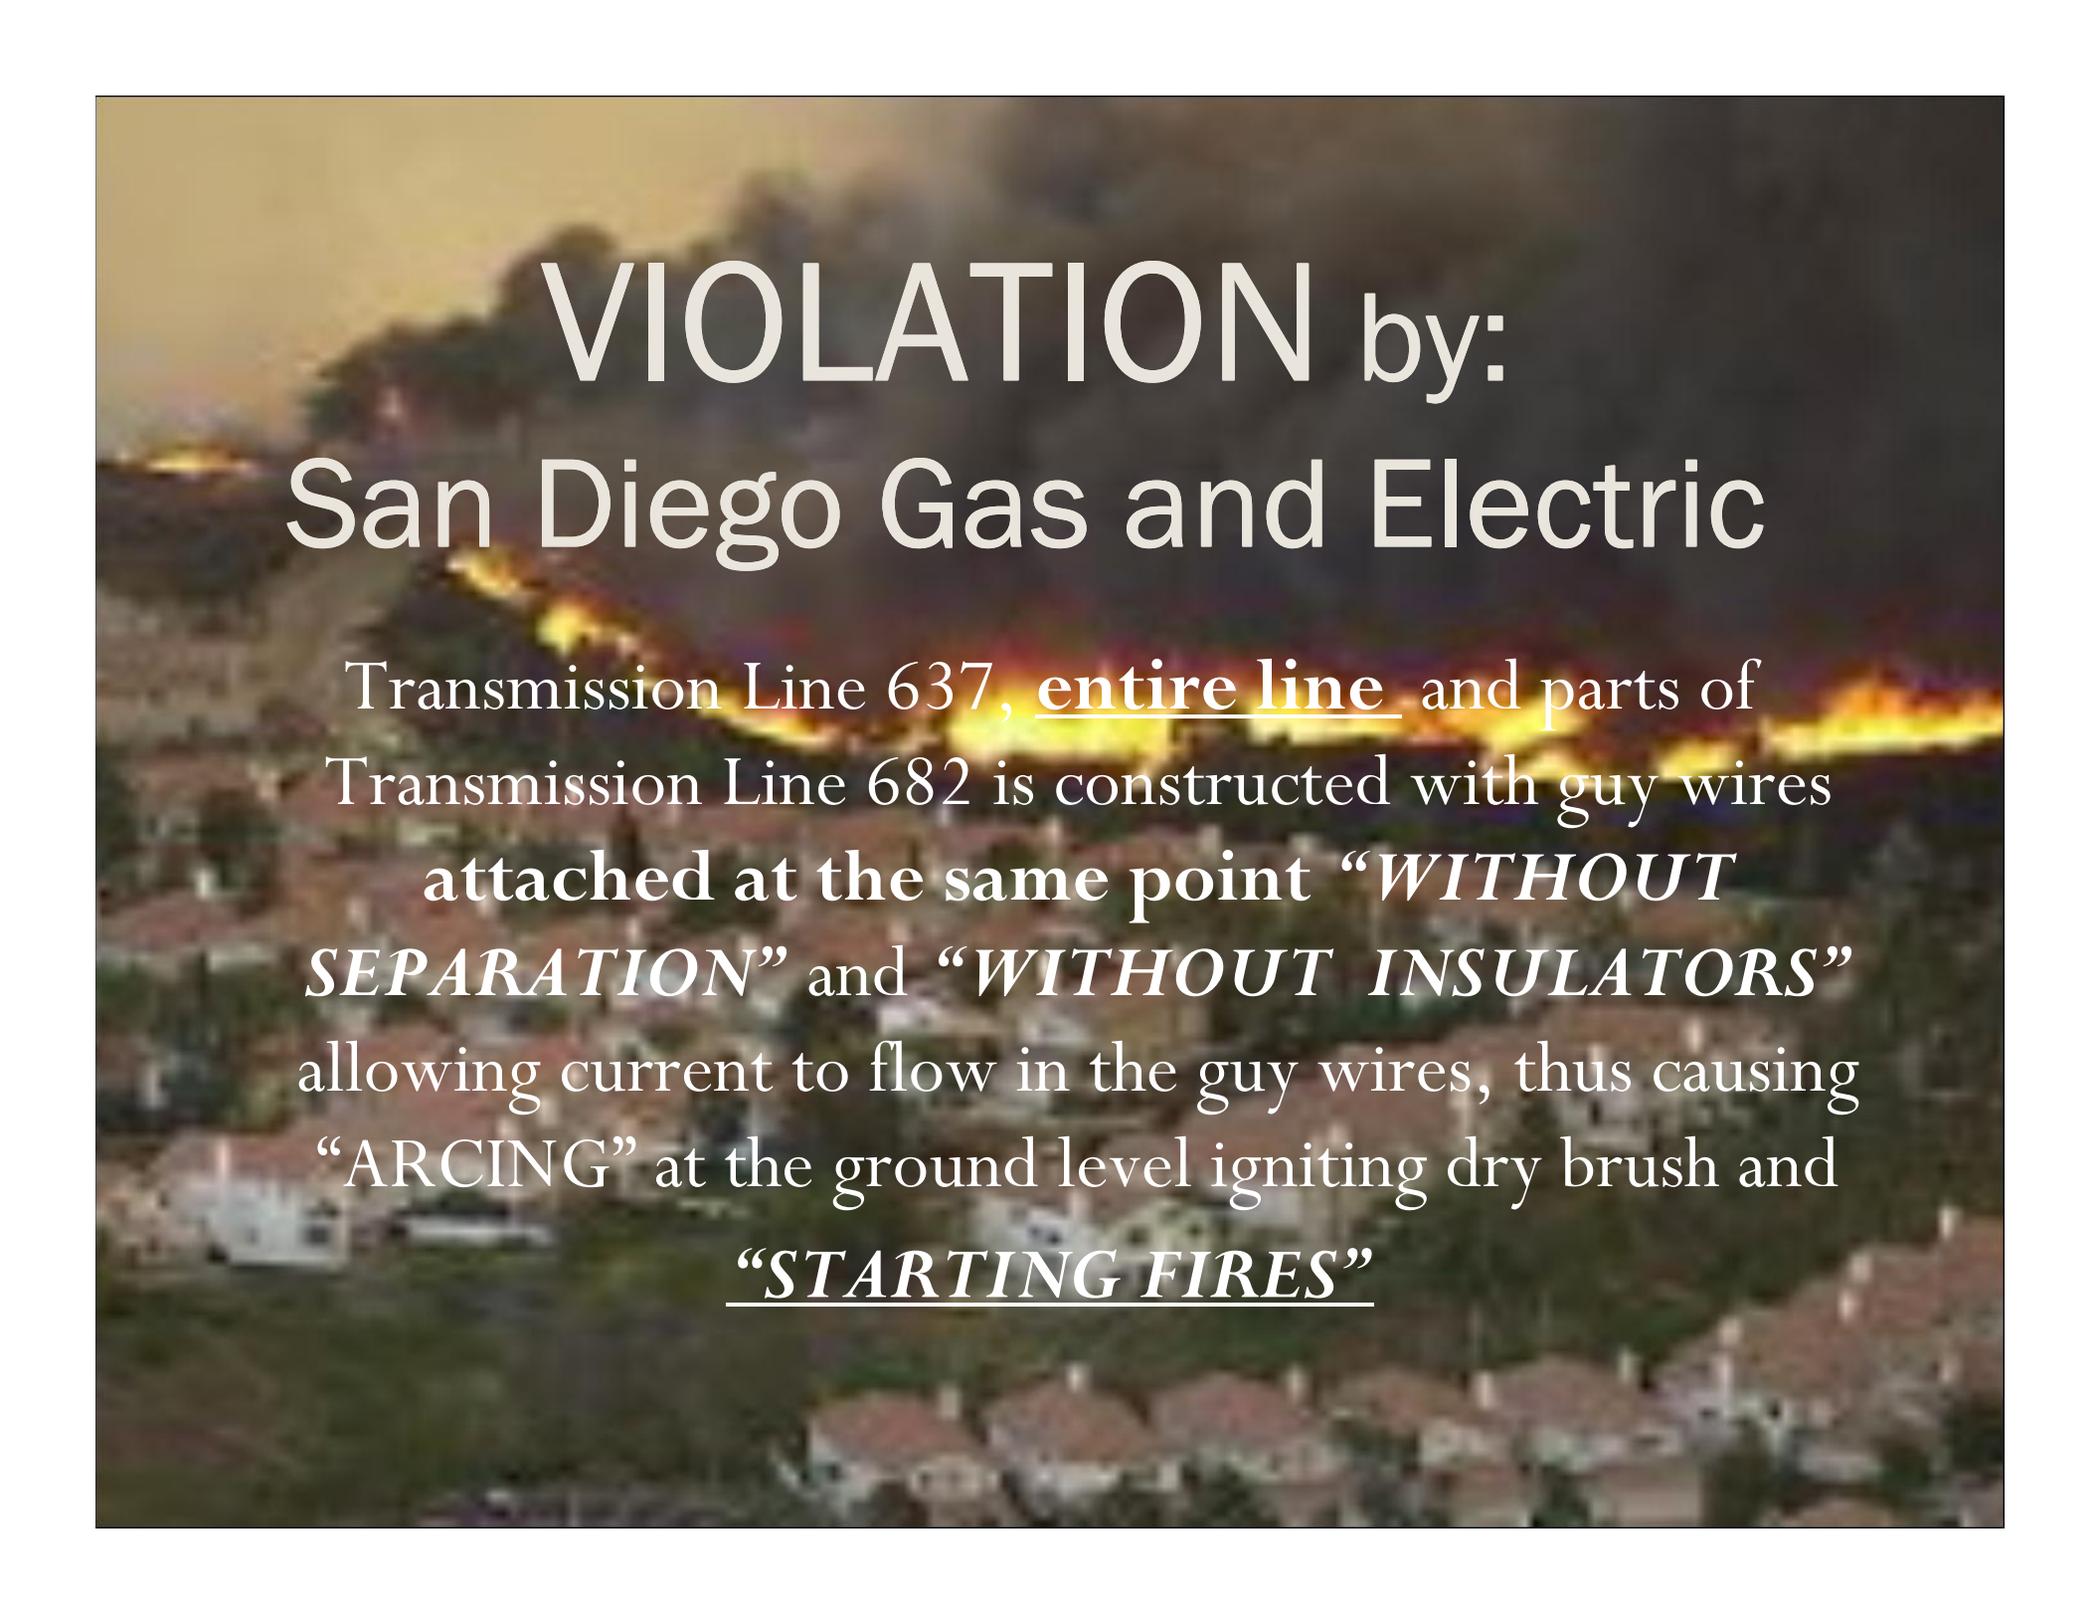
VIOLATION by: San Diego Gas and Electric

Transmission Line 637, entire line and parts of Transmission Line 682 is constructed with guy wires attached at the same point “*WITHOUT SEPARATION*” and “*WITHOUT INSULATORS*” allowing current to flow in the guy wires, thus causing “ARCING” at the ground level igniting dry brush and “*STARTING FIRES*”

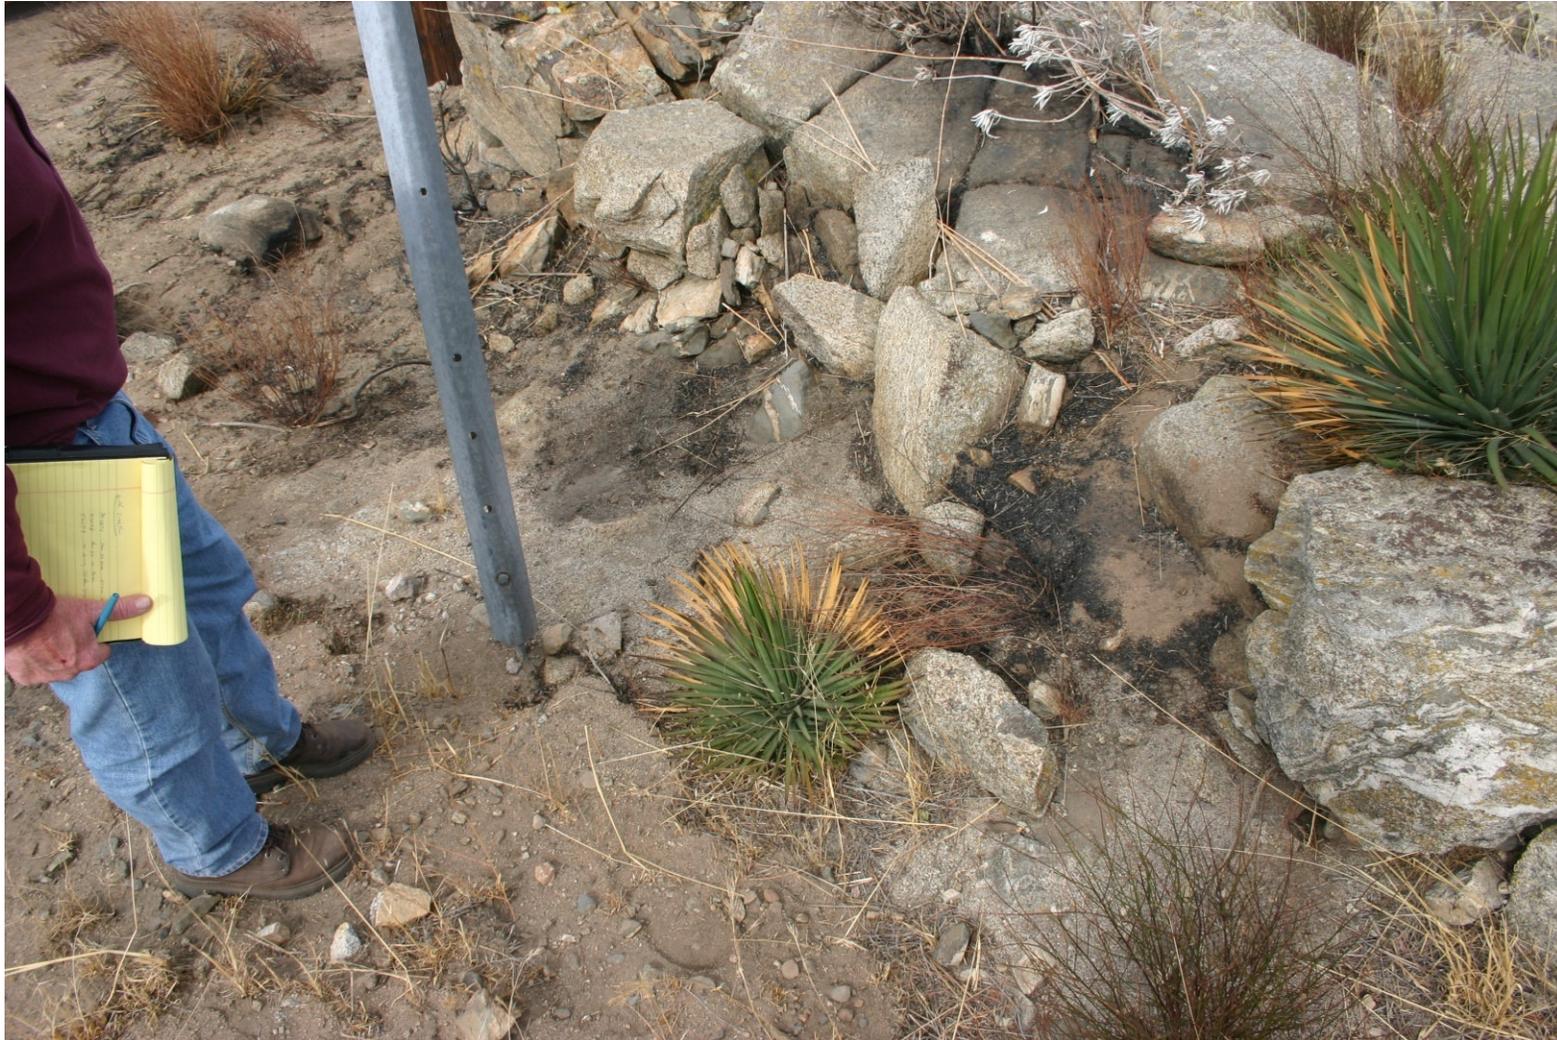
START OF Witch FIRE !!!!

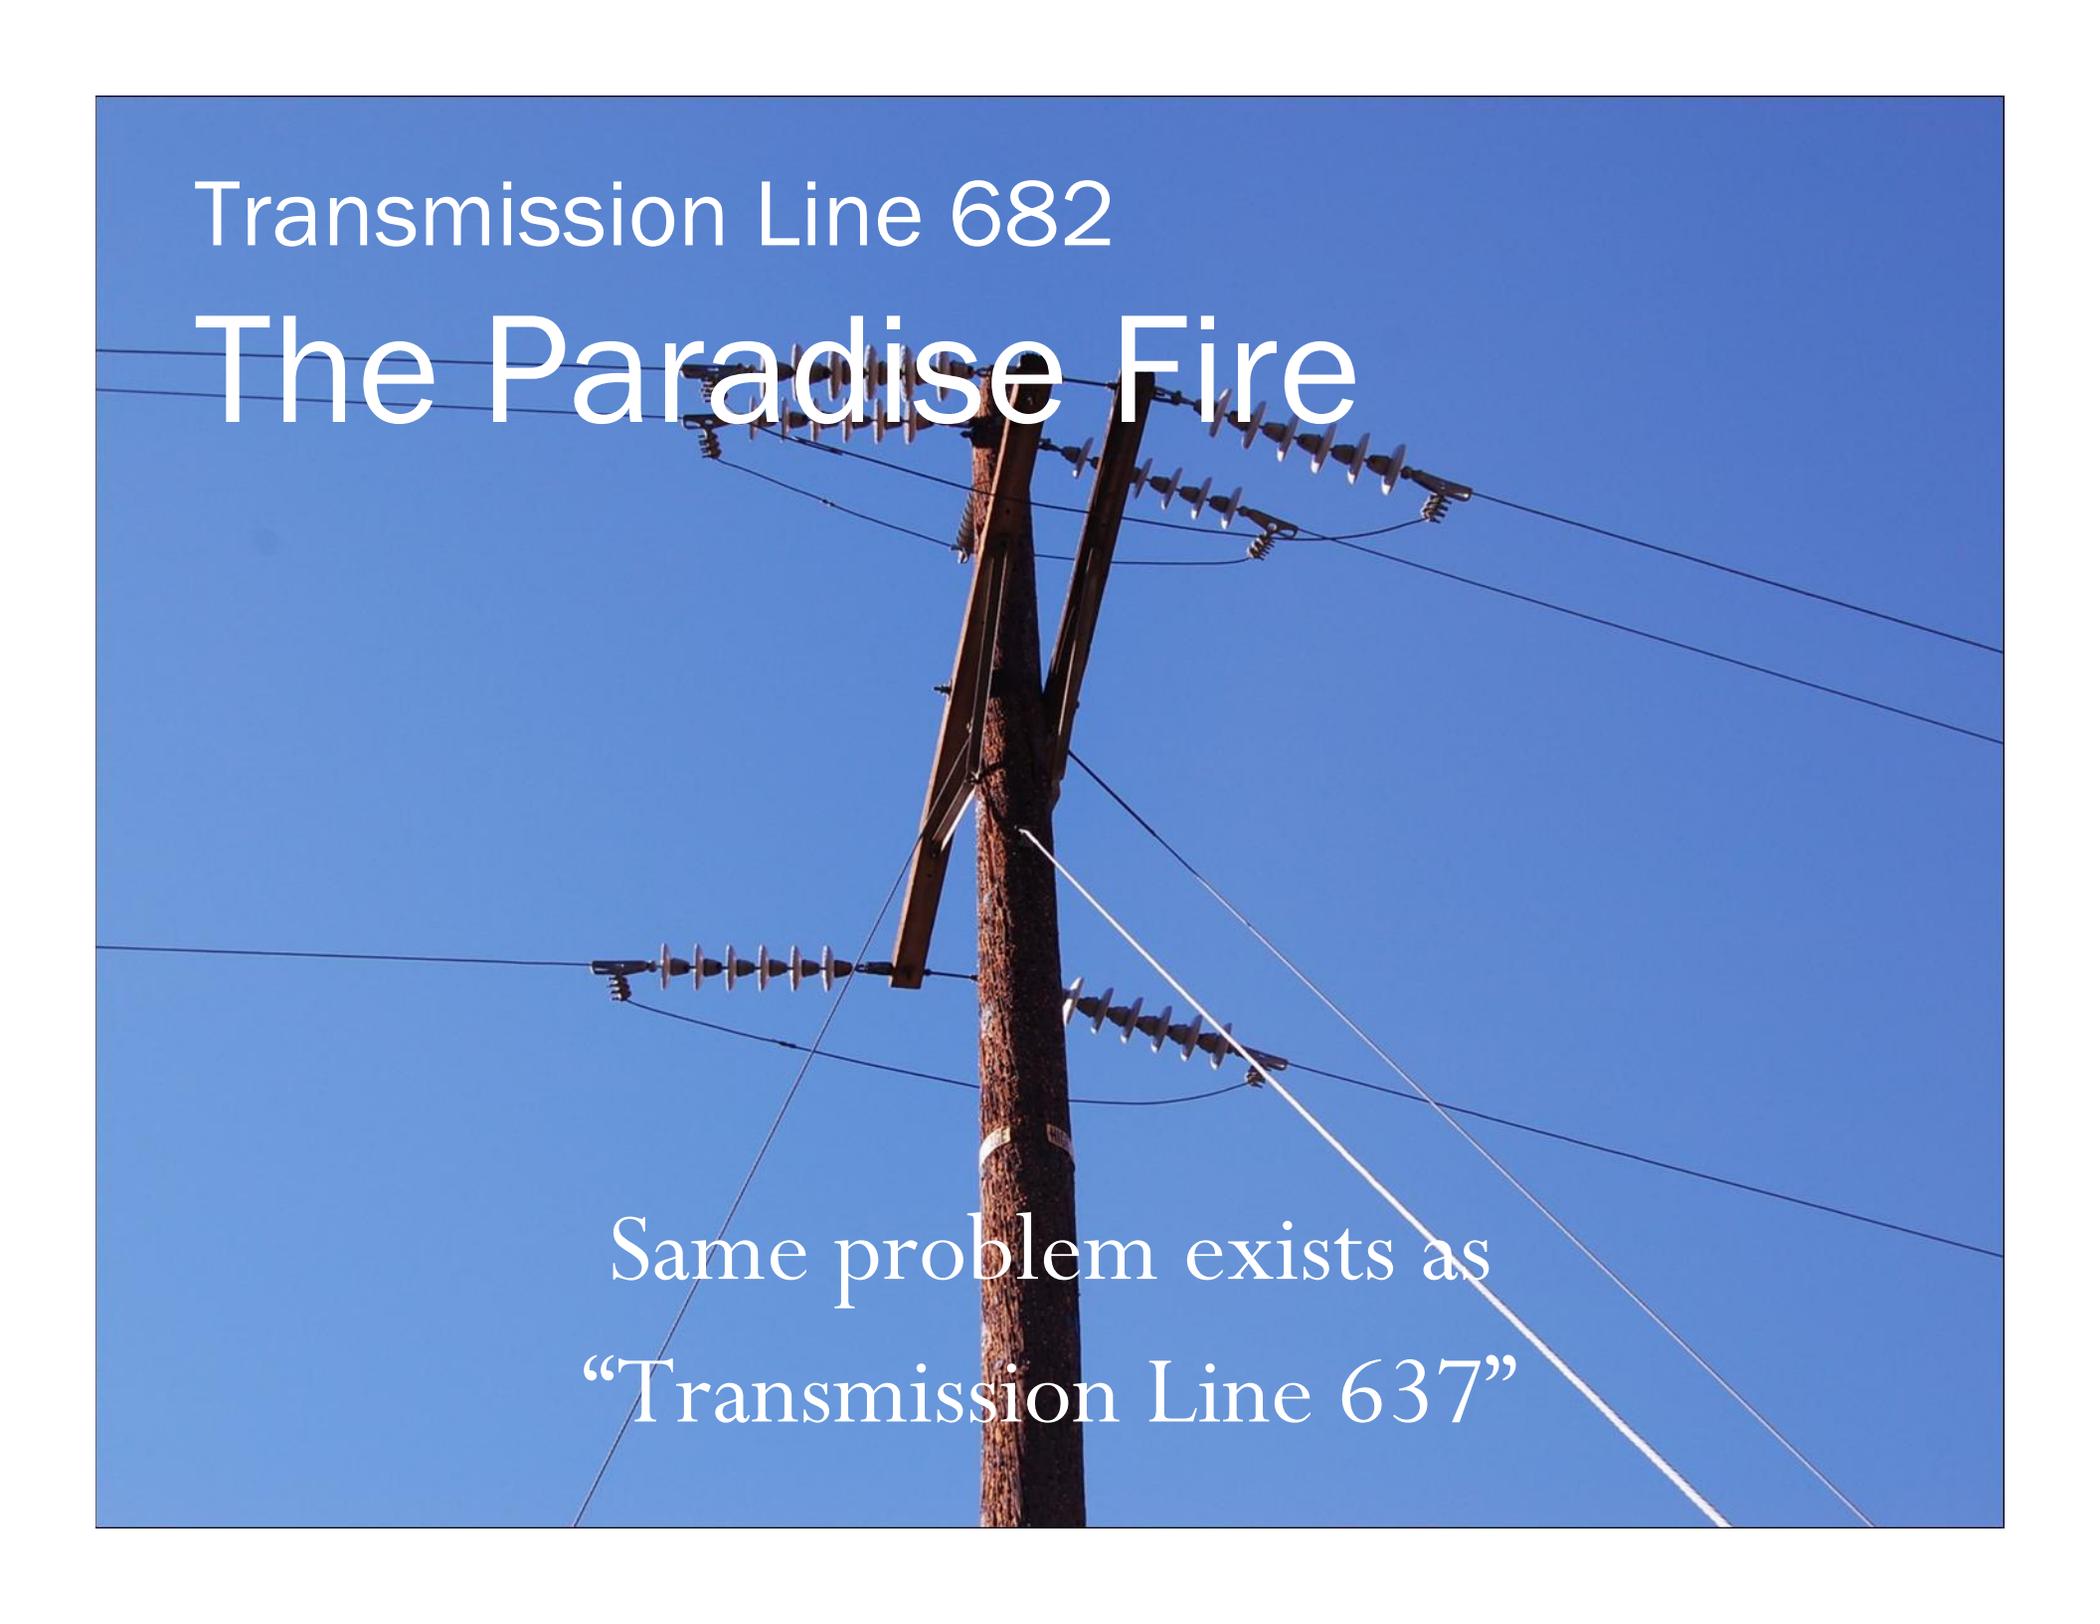
Transmission Line 682

The Paradise Fire

- **Same Problem as Transmission line 637**
- **The Down Guy Construction is a system wide problem.**
 - **Found the start of the Paradise Fire 12/15/07.**
 - **The Cedar Fire overlaps with the Witch Fire.**
- **Pulled samples from poles associated with the Cedar Fire and not the Witch Fire. Positive for Carbon and Arcing.**
