PROPERTY CONDITION REPORT

Client(s): Mr. & Mrs. John Buyers
Property: 23233 Mill Creek Road
Any Town, CA. 99999
Realtor: Ms. Nanci Wiseagent
Date: October 15, 2012
Inspector: Rick DeBoard - Certification #1051
Report #: Sample 30 Year Old House

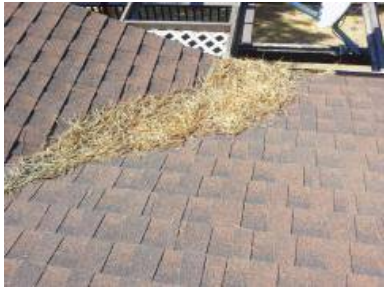
- STYLE:** Gable.
- ROOF PITCH(S):** The approximate roof pitch is 4:12.
- TYPE & CONDITION:** Good condition.
The roof covering is Architectural Composition Shingles. (Also called Dimensional Composition).
[There is debris accumulating on the roof surfaces](#), we recommend that roof surfaces are cleaned on a regular basis.

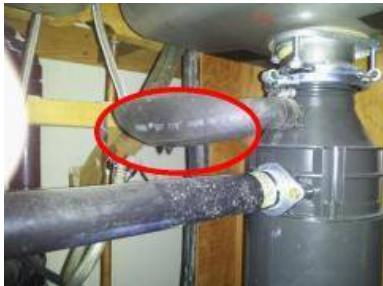
KITCHEN

- SINK(S):** Good condition. Stainless Steel.
- FAUCET(S):** Good condition.
- GARBAGE DISPOSAL:** Good condition.
- RANGE/BURNERS:** Good condition.
- OVEN(S):** Good condition. Self-cleaning, (for the sake of time the self-cleaning cycle is not tested).
Electric.
- EXHAUST FAN / RANGE HOOD:** Good condition. The exhaust fan installed is a recirculating type. These type fans merely take the air above your range and recirculates it into the room, and do not exhaust the air to the exterior of the dwelling.
- DISHWASHER:** Fair condition. [Dishwasher is leaking at the drain line.](#)
- COUNTER SURFACES:** Good condition. Counters are Formica, (plastic laminate).
- CABINETS:** Good condition.
- WINDOWS:** Good condition.
- WALLS:** Good condition. Wall covering.
- FLOORS, FLOOR COVERINGS:** Good condition. Tile.

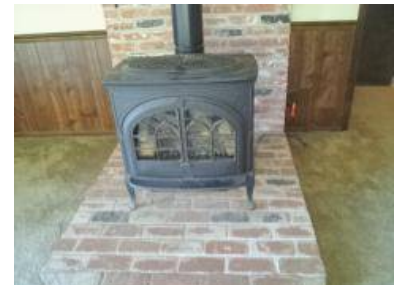
WOOD BURNING OR GAS STOVE This is a gas stove, NOT for burning of solid fuels.

Good condition. The hearth extends out from the firebox opening adequately.

Unable to determine if flue needs cleaning. A flue cap is installed.

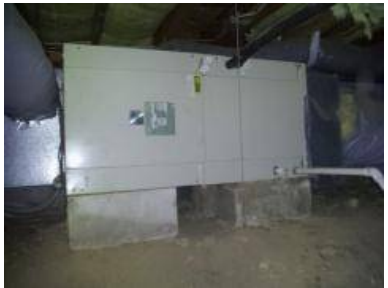
LOCATION: In the underfloor crawlspace.

OVERALL CONDITION: Fair condition.

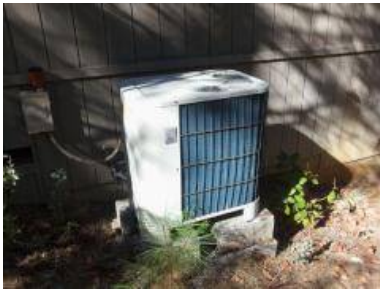
LOCATION:	<p>This is a split system, the condenser is located outdoors at the right of the building. The refrigeration coils and the coil plenum are attached to the furnace in heating system #1.</p> <p>Services the rooms at the upper floor.</p> <p>Downstairs has no air conditioning installed.</p>

OVERALL CONDITION:	Good condition.	
TYPE:	Central air conditioning type system.	
ENERGY SOURCE:	220 Volt. Electrical disconnect is present, as typically required.	
AGE OF UNIT:	8-10 Years.	
AIR TEMPERATURE DROP:	Between 14 & 20 degrees drop from Return Air Temperature. This is within typical parameters.

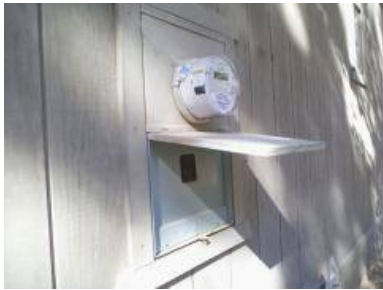
LOCATION: Exterior, at right side of the house.

CONDITION: Good condition.

SAFETY CONCERNS: No visibly apparent safety concerns were noted at this panel.

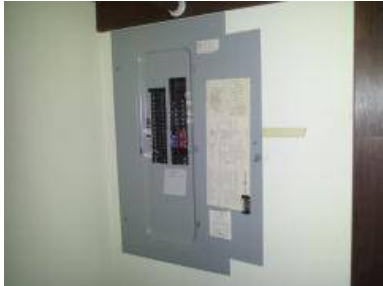
LOCATION: Interior of the structure at the entry closet.

CONDITION: Fair condition.

SAFETY CONCERNS: *Safety Concern - The following are potential safety concerns which were found at this panel:*

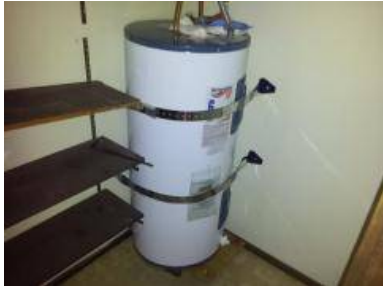
LOCATION: Located at the closet in the downstairs bathroom.

SIZE: 50 Gallons.

FUEL TYPE: Powered by electricity.
